Item No: **15.4**

Subject: **TARLTON STREET TREE ASSESSMENT AND TREE RENEWAL**

Tarlton Street *Quercus ilex* (Holm Oak) Assessment Report

**Prepared for Council
Compiled by Ben Hall, Technical Arboriculture Officer**

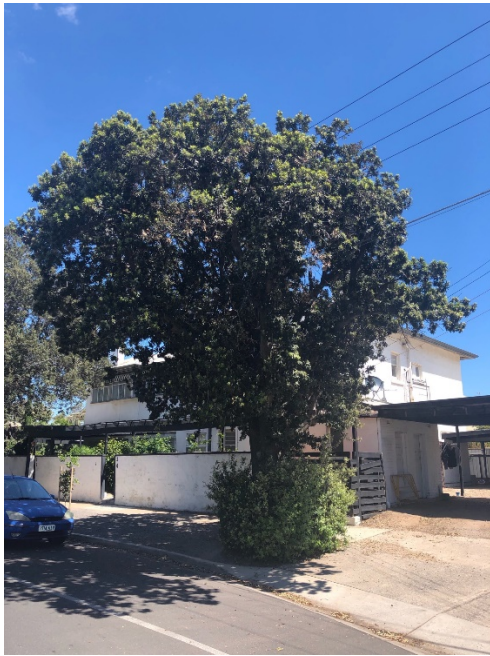
Tree 1

Health: Good

Structure: Good-fair

ULE: 20-30 years

Risk rating: Low

Recommendation: Retain - deadwood and provide clearance to service wires. Reduce suckering via hedging method.

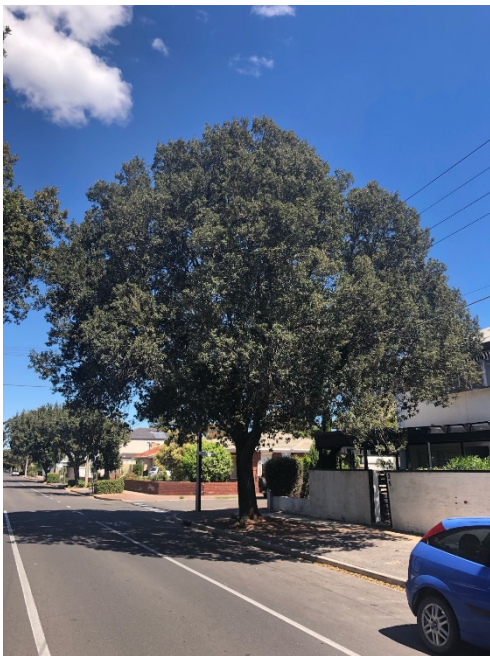
Tree 2

Health: Good

Structure: Good

ULE: 20-30 years

Risk rating: Low

Recommendation: Retain - minor reduction from property gutter and minor dead-wood over roadway.

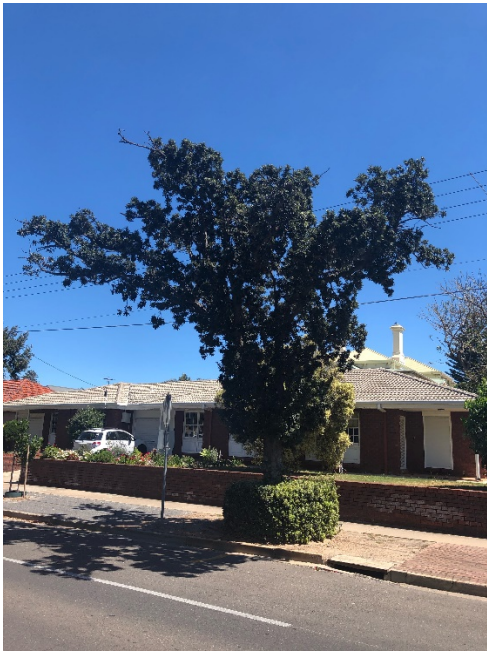
Tree 3

Health: Fair

Structure: Fair-poor

ULE: <5 years

Risk rating: Low

Recommendation: Retain - minor deadwood and hedge suckers. Tree is in reduced form from years of dieback. New growth throughout and stunted form presents a tree with minimal risk.

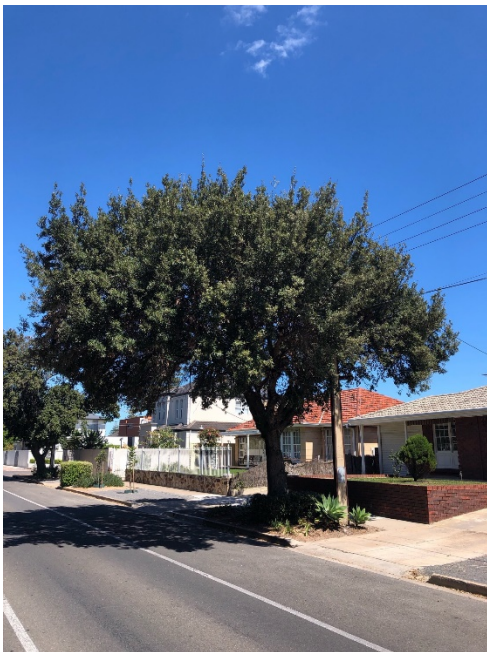
Tree 4

Health: Good

Structure: Good-fair

ULE: 20-30 years

Risk rating: Low

Recommendation: Retain - no action required (recently pruned).

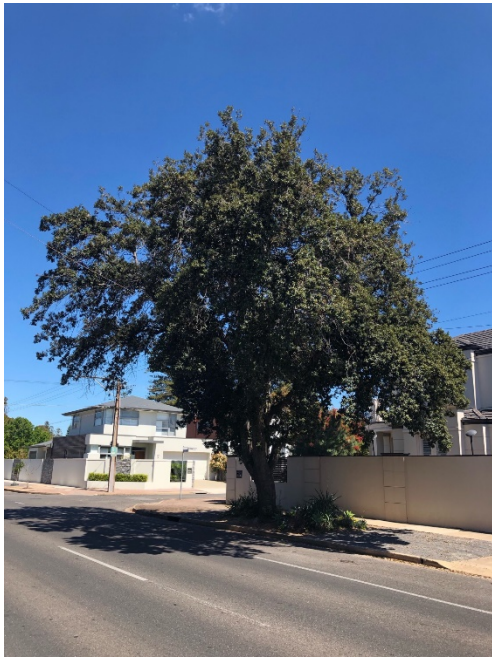
Tree 5

Health: Good-fair

Structure: Good-fair

ULE: 20-30 years

Risk rating: Low

Recommendation: Retain - dead-wood and remove suckers.

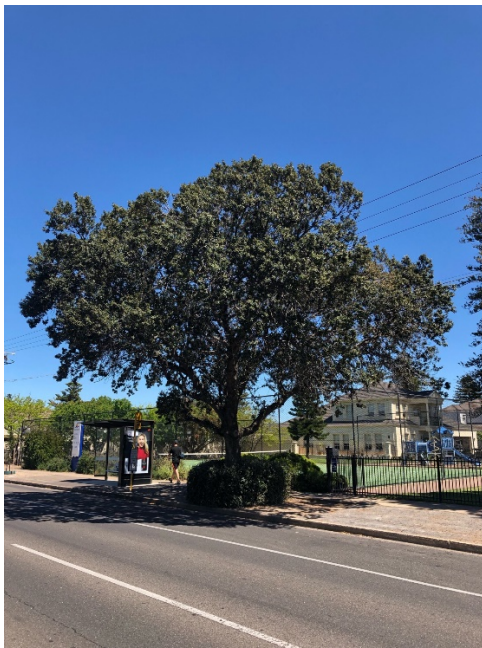
Tree 6

Health: good

Structure: good

ULE: 20-30years

Risk rating: Low

Recommendation: Retain - minor deadwood, manage suckers with hedging method.

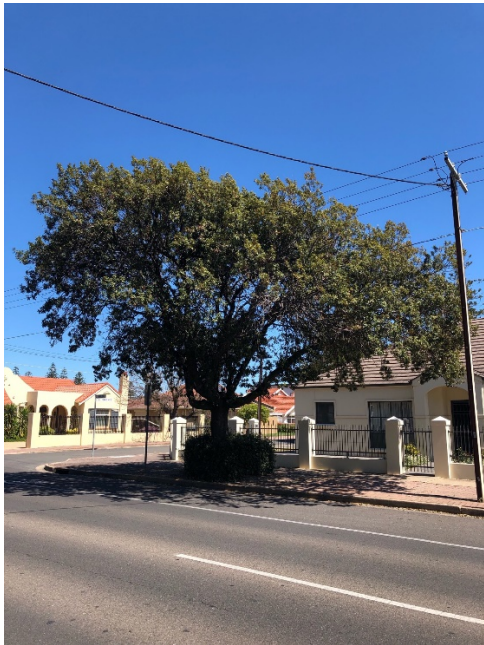
Tree 7

Health: Good

Structure: Good-fair

ULE: 20-30 years

Risk rating: Low

Recommendation: Retain - minor deadwood manage suckers (retain hedging approach)
Existence of unnecessary pavers on verge which is a less favourable application for the tree.

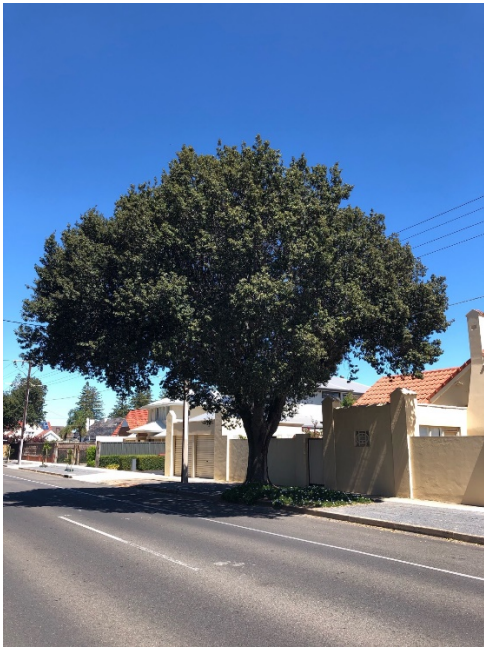
Tree 8

Health: good-fair

Structure: good-fair

ULE: 10-20 years

Risk rating: Low

Recommendation: Retain - dead-wood required and slight lift over road. Canker and fungal activity is present in this tree. Tree is compartmentalising well and currently coping with pathogenic infections.

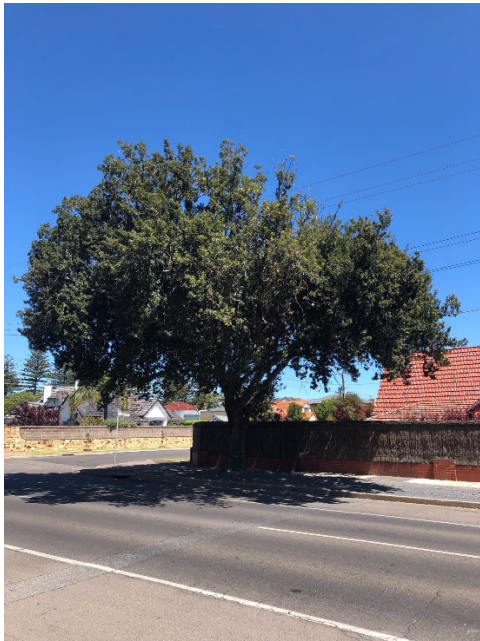
Tree 9

Health: good

Structure: good-fair

ULE: 20-30 years

Risk rating: Low

Tree structure hindered by SAPN vegetation clearance.

Recommendation: Retain - no action required.

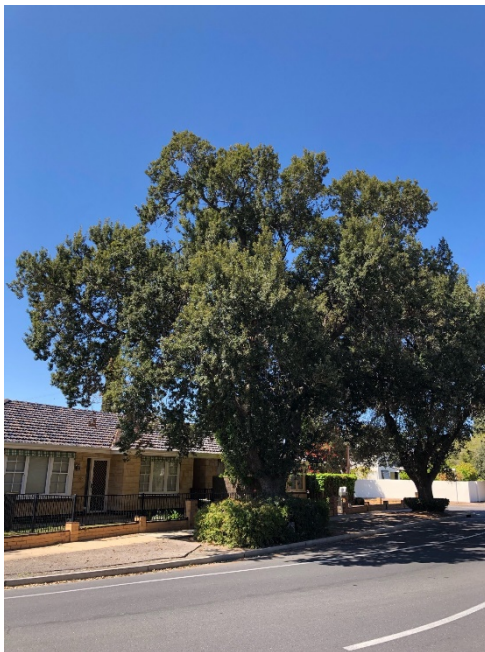
Tree 10

Health: Good

Structure: Good to fair (managed suckering)

ULE: 20-30 years

Risk rating: Low

Recommendation: Retain - minor dead-wood and lift over roadway require. Existence of bitumen on verge which is a less favourable application for the tree.

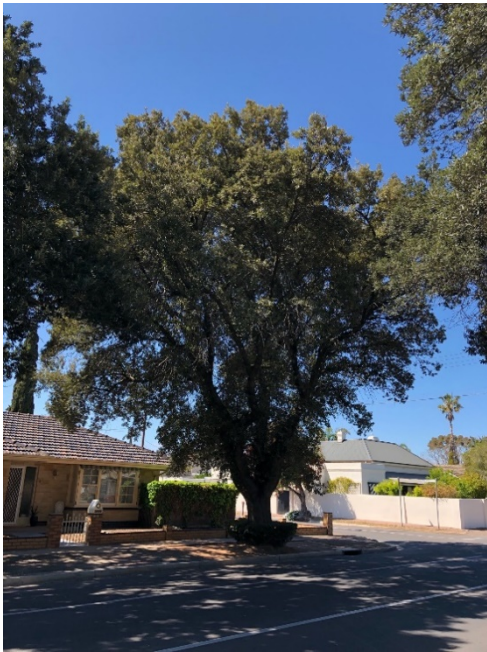
Tree 11

Health: Good

Structure: Good to fair (managed suckering)

ULE: 20-30 years

Risk rating: Low

Existence of bitumen on verge which is a less favourable application for the tree.

Recommendation: Retain - minor dead-wood.

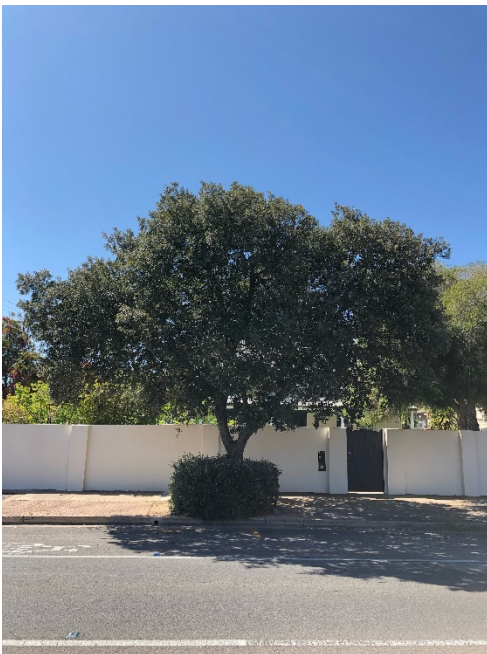
Tree 12

Health: Good

Structure: Good to fair (managed suckering)

ULE: 20-30 years

Risk rating: Low

Existence of bitumen on verge which is a less favourable application for the tree.

Recommendation: Retain - no pruning required.

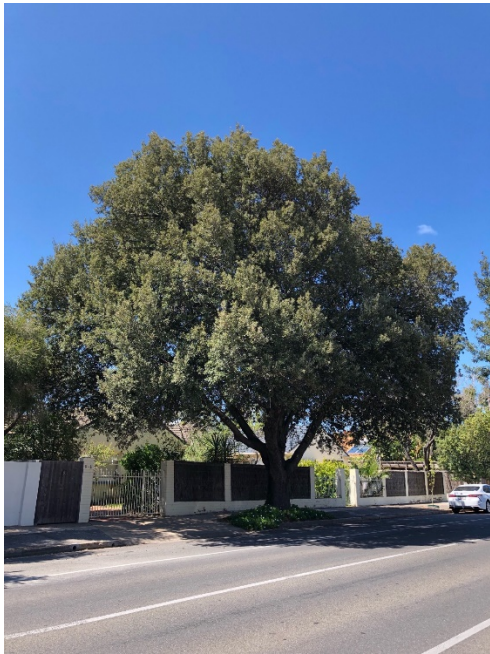
Tree 13

Health: Good

Structure: Good to fair

ULE: 20-30 years

Risk rating: Low

Existence of bitumen on verge which is a less favourable application for the tree.

Recommendation: Retain - minor dead-wood.

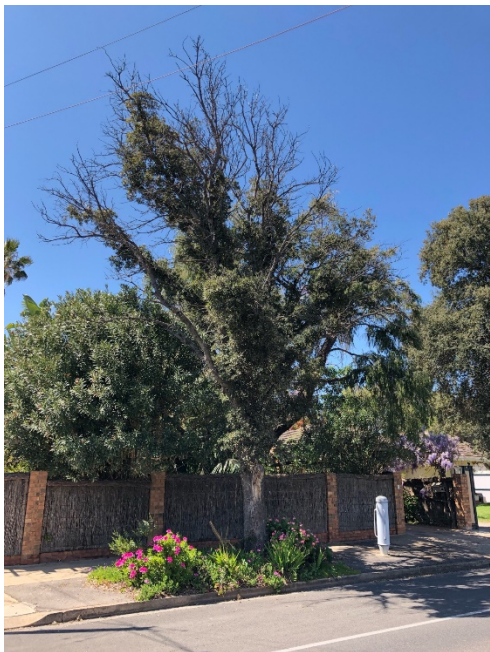
Tree 14

Health: Poor (in senescence)

Structure: Poor (primary union has failed)

ULE: Replace

Risk rating: Medium

Recommendation: Remove and replace with 1

London Plane Tree. Existence of bitumen on verge which is a less favourable application for the tree.

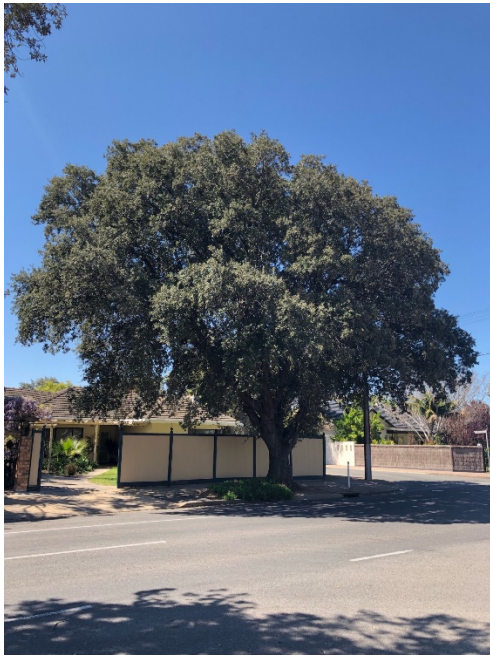
Tree 15

Health: Good

Structure: Good

ULE: 20-30 years

Risk rating: Low

Recommendation: Retain - minor lift over residential side required. Existence of bitumen on verge which is a less favourable application for the tree.

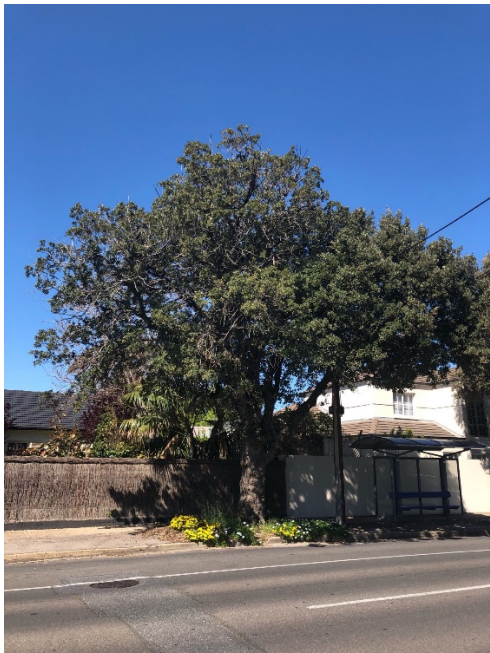
Tree 16

Health: Good

Structure: Good

ULE: 20-30 years

Risk rating: Low

Recommendation: Retain - Some minor vegetation reduction required to accommodate street light and service wire. Existence of bitumen on verge which is a less favourable application for the tree.

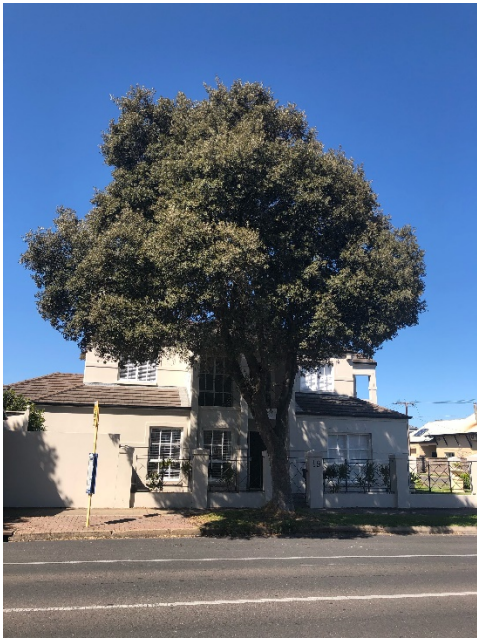
Tree 17

Health: Good

Structure: Good

ULE: 20-30 years

Risk rating: Low

Recommendation: Retain – No action required

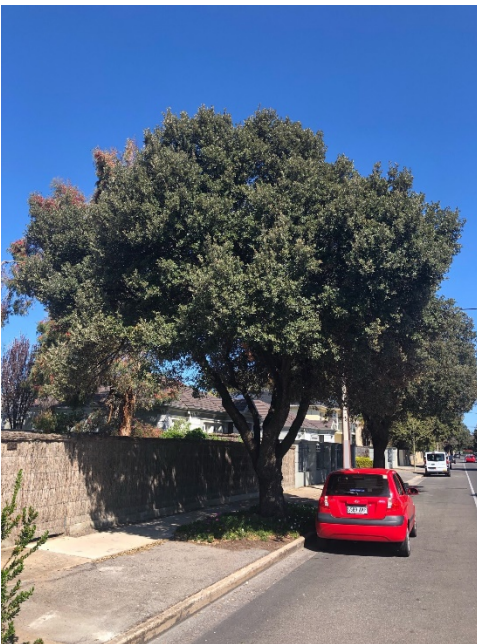
Tree 18

Health: Good

Structure: Good

ULE: 20-30 years

Risk rating: Low

Recommendation: Retain - no pruning action required. Existence of bitumen on verge which is a less favourable application for the tree.

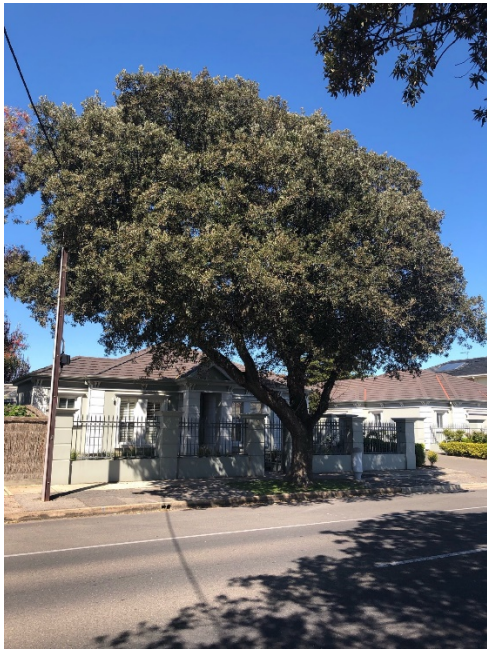
Tree 19

Health: Good

Structure: Good

ULE: 20-30 years

Risk rating: Low

Recommendation: Retain - no pruning required.
Existence of Artificial Turf on verge which is a less favourable application for the tree.

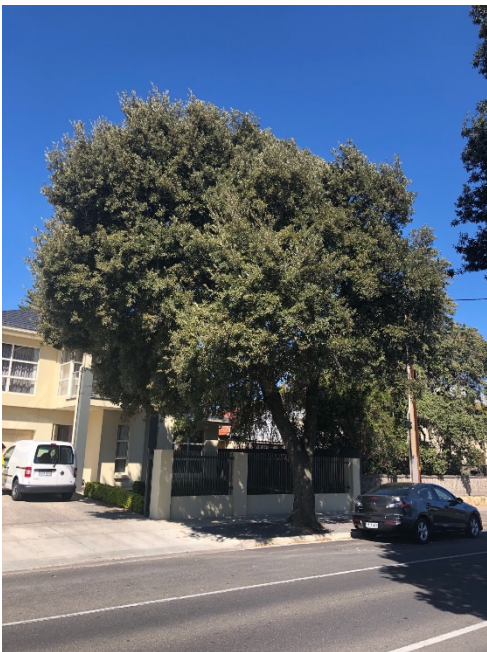
Tree 20

Health: Good

Structure: Good

ULE: 20-30 years

Risk rating: Low

Recommendation: Retain - minor lift over residential driveway required

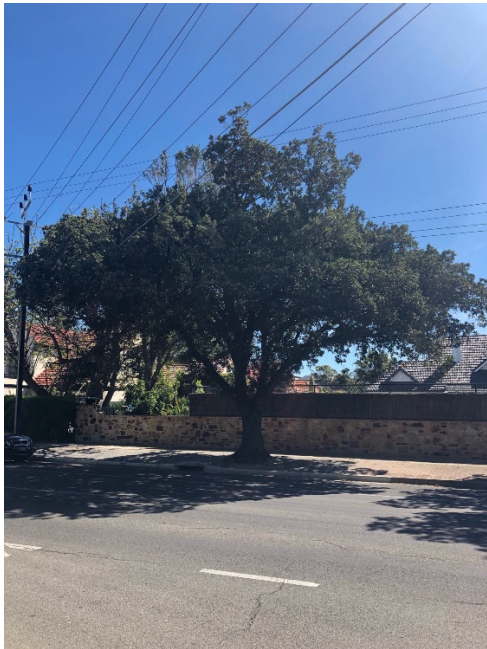
Tree 21

Health: Good

Structure: Good

ULE: 20-30 years

Risk rating: Low

Recommendation: Retain – provide tunnelling clearance to service wires.

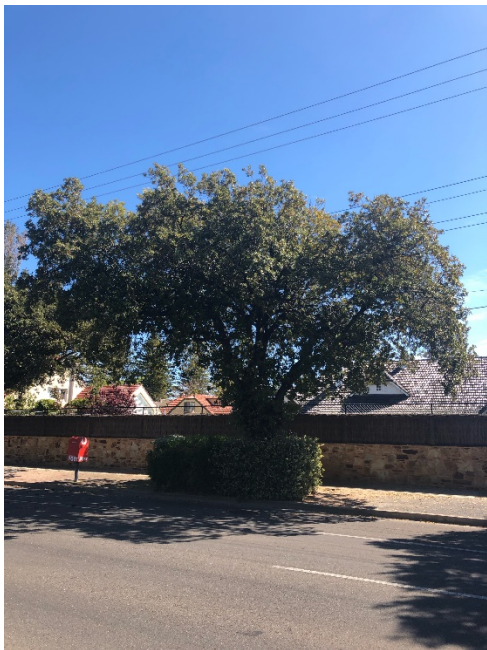
Tree 22

Health: Good

Structure: Good-fair (managed suckering)

ULE: 20-30 years

Risk rating: Low

Recommendation: Retain – maintain hedged suckers.

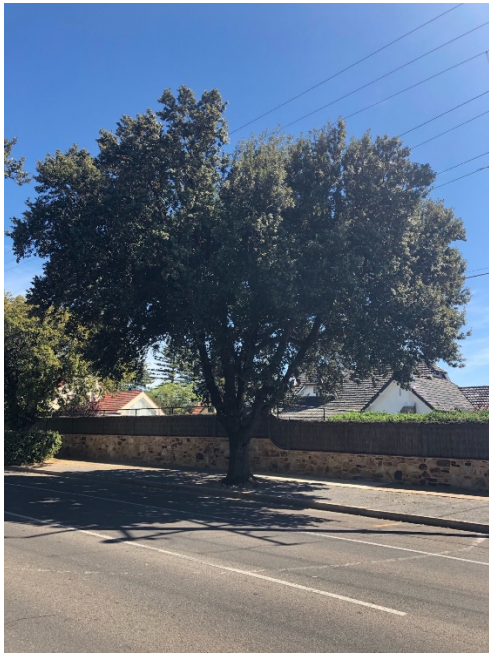
Tree 23

Health: Good

Structure: Good

ULE: 20-30 years

Risk rating: Low

Recommendation: Retain – no action required

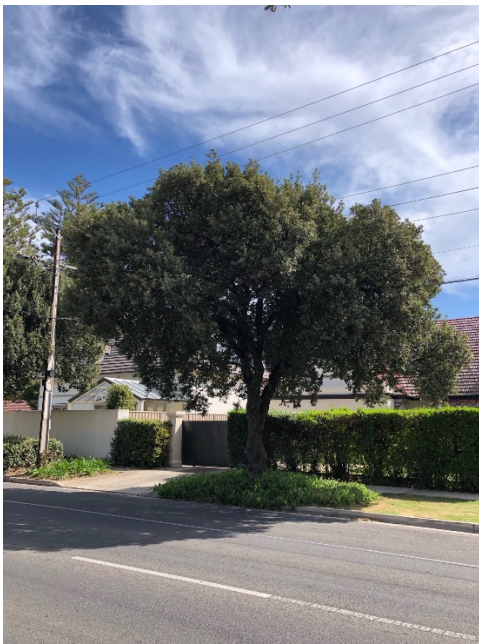
Tree 24

Health: Good

Structure: Good

ULE: 20-30 years

Risk rating: Low

Recommendation: Retain – no action required.

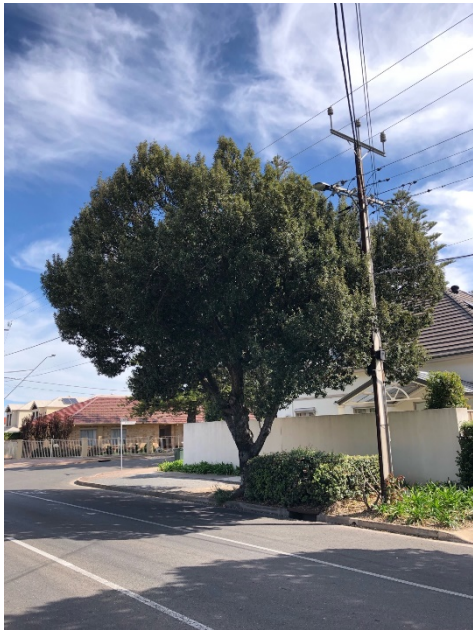
Tree 25

Health: Good

Structure: Good

ULE: 20-30 years

Risk rating: Low

Recommendation: Retain – provide minor clearance for street lighting.

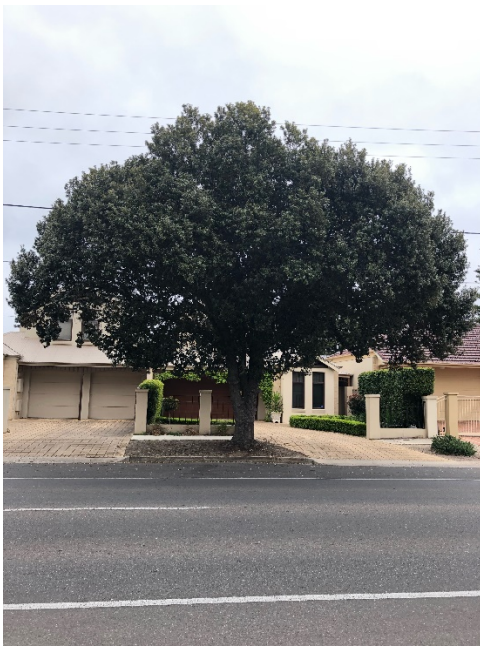
Tree 26

Health: Good

Structure: Good

ULE: 20-30 years

Risk rating: Low

Recommendation: Retain - slight lift over driveway required. Driveway damage noted.

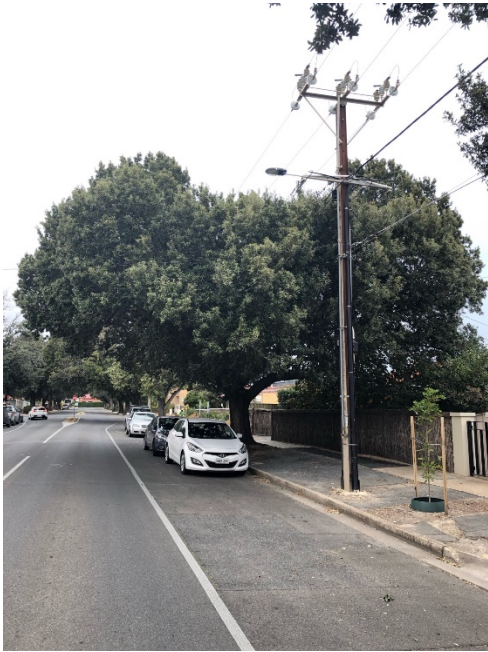
Tree 27

Health: Good

Structure: Good-fair

ULE: 20-30 years

Risk rating: Low

Recommendation: Retain - minor tunnelling clearance required for service wires. Tree displays prominent effects of SAPN vegetation clearance.

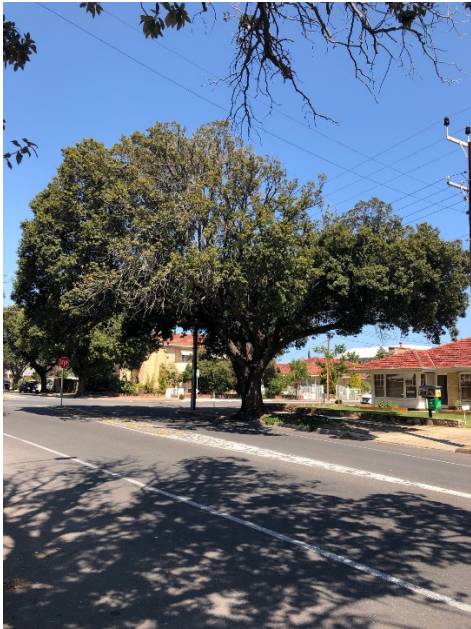
Tree 28

Health: Good-fair

Structure: Good-fair

ULE: 10-20 years

Risk rating: Low

Recommendation: Retain - minor dead-wooding required. Tree displays prominent effects of SAPN vegetation clearance.

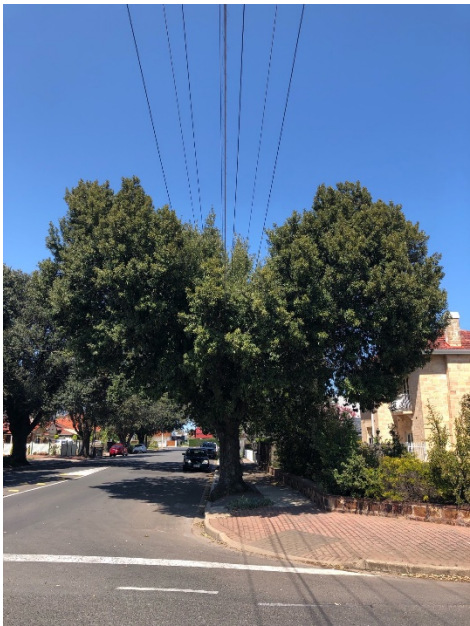
<p>Tree 29</p> <p>Address: side of 65 Whyte Street</p> <p>Health: Good</p> <p>Structure: Good-fair</p> <p>ULE: 10-20 years</p> <p>Risk rating: Low</p> <p>Regulatory Status: Regulated</p> <p>Powerlines: overhead low/high voltage present</p> <p>Recommendation: Retain - minor deadwood.</p> <p>Existence of bitumen on verge which is a less favourable application for the tree. Evidence of damage from continued infrastructure reinstatement. Tree displays prominent effects of SAPN vegetation clearance.</p>

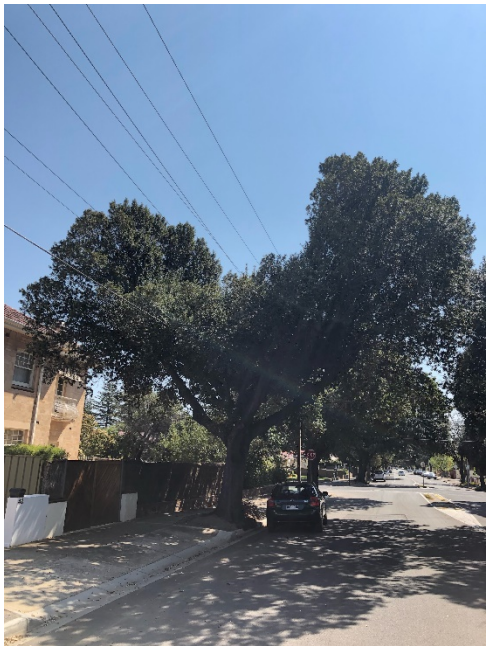
<p>Tree 30</p> <p>Address: side of 65 Whyte Street</p> <p>Health: Good</p> <p>Structure: Good-fair</p> <p>ULE: 10-20 years</p> <p>Risk rating: Low</p> <p>Regulatory Status: uncontrolled</p> <p>Powerlines: overhead low/high voltage present</p> <p>Recommendation: Retain – existence of bitumen on verge which is a less favourable application for the tree. Tree displays prominent effects of SAPN vegetation clearance.</p>

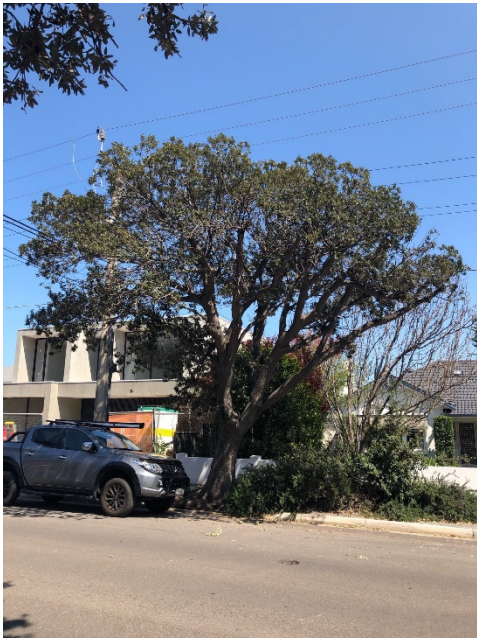
Tree 31

Health: Fair

Structure: Good-fair

ULE: 5-10 years

Risk rating: Low

Recommendation: Retain - minor deadwood and clearance provided for service wires. Review health in 12 months.

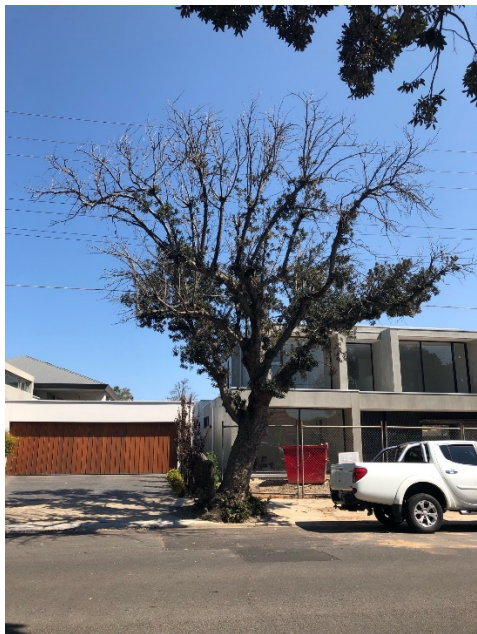
Tree 32

Health: Poor (in Senescence)

Structure: Fair-average

ULE: Replace

Risk rating: Medium

Recommendation: Remove - replace with Tuckeroo to accommodate overhead powerlines. To be planted centrally to property of 44 (new development). With driveway tight to either side of this tree it is seen to be in a comprising position likely contributing to the decline along with excessive vegetation clearance issued by SAPN.

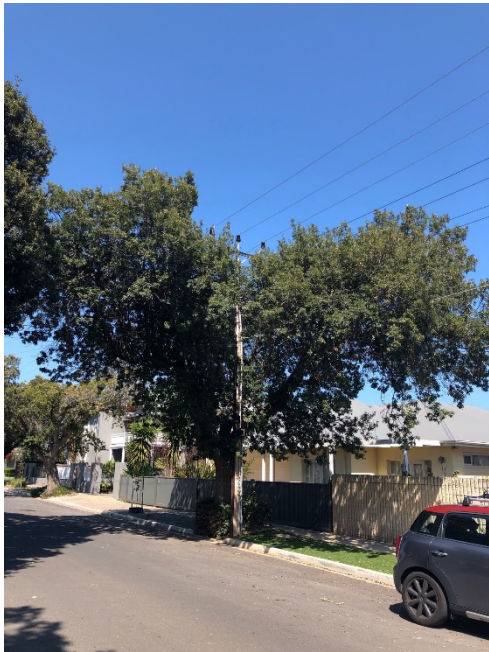
Tree 33

Health: Good

Structure: Fair

ULE: 10-20 years

Risk rating: Low

Recommendation: Retain - tree is coexisting with overhead infrastructure and stoby pole reasonably well. Some minor clearance required to further accommodate street lighting. Tree shows signs of excessive clearance from road way, damage to base for infrastructure reinstatement. Existence of artificial turf on the verge which is a less favourable application for the tree.

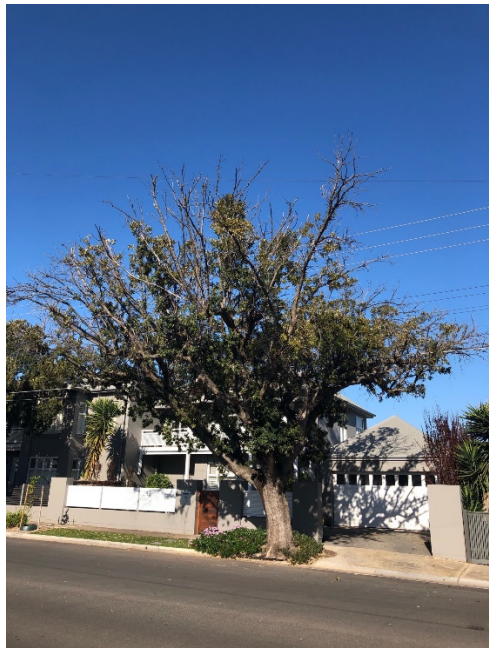
Tree 34

Health: Poor (in senescence)

Structure: Fair

ULE: Replace

Risk rating: Medium

Recommendation: Remove - replace with Tuckeroo to accommodate overhead powerlines. Tree has major dieback throughout with the only live foliage being epicormic growth. Tree likely to have have been set into decline from a number of factors. Existence of artificial turf on the verge which is a less favourable application for the tree.

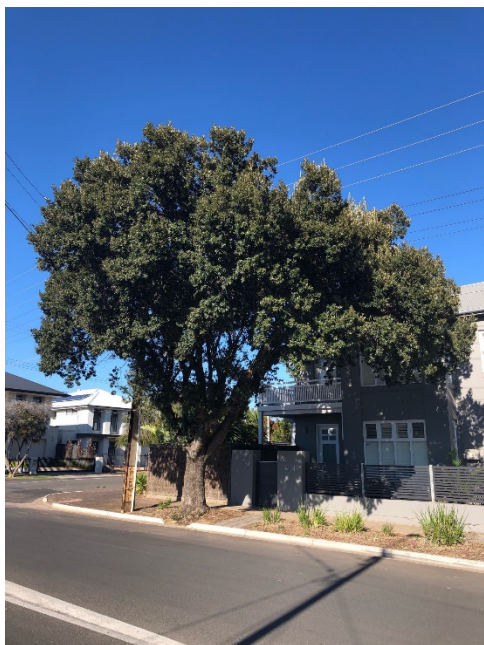
Tree 35

Health: Good

Structure: Good

ULE: 10-20 years

Risk rating: Low

Recommendation: Retain – issue tunnelling clearance for service wires.

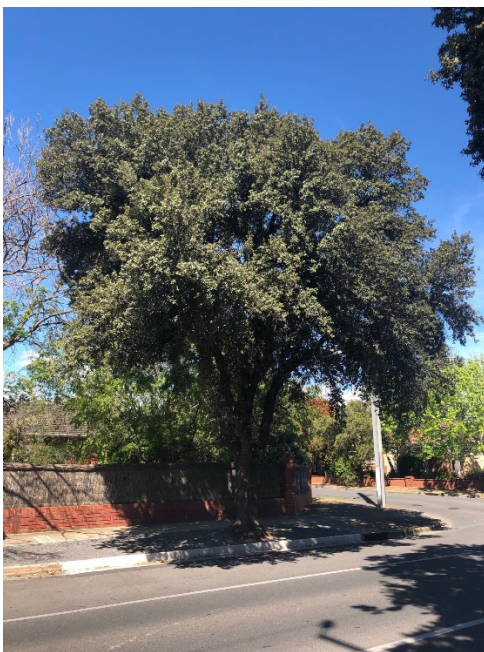
Tree 36

Health: Good

Structure: Good

ULE: 20-30 years

Risk rating: Low

Recommendation: Retain – no action required.

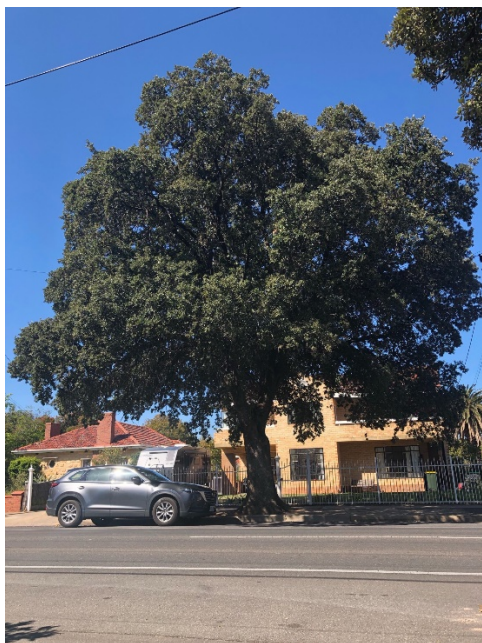
Tree 37

Health: Good

Structure: Good

ULE: 20-30 years

Risk rating: Low

Recommendation: Retain - minor lift over residential side required. Existence of bitumen on verge which is a less favourable application for the tree.

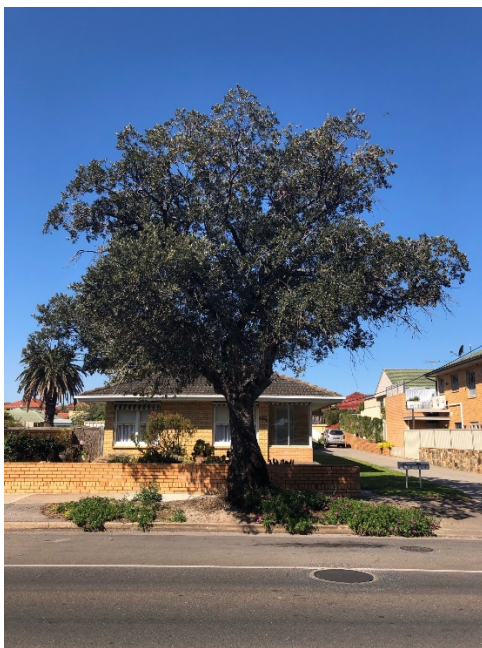
Tree 38

Health: Good-fair

Structure: Good

ULE: 20-30 years

Risk rating: Low

Recommendation: Retain - minor dead-wooding required. Existence of bitumen on verge which is a less favourable application for the tree.

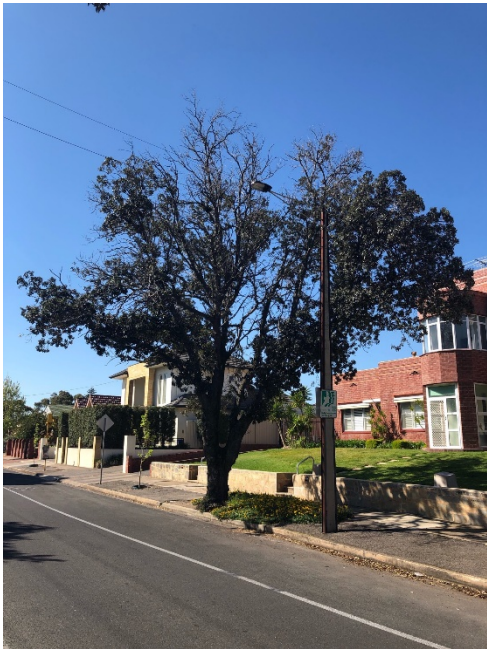
Tree 39

Health: Poor (in senescence)

Structure: Good

ULE: Replace

Risk rating: Medium

Recommendation: Remove - replace with a London Plane. Existence of bitumen on verge which is a less favourable application for the tree.

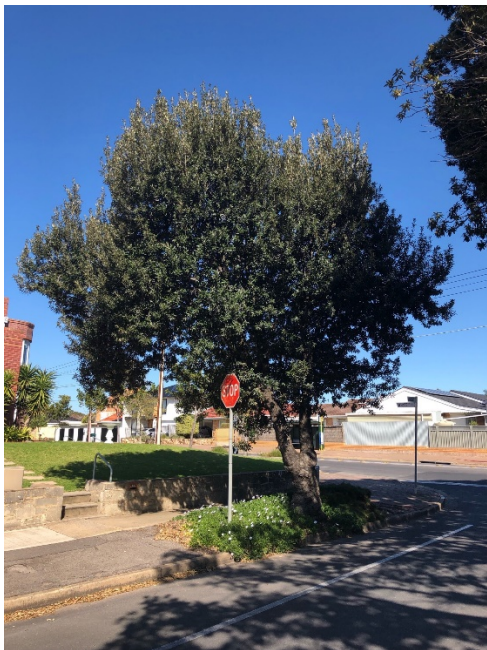
Tree 40

Health: Good

Structure: Good

ULE: 20-30 years

Risk rating: Low

Recommendation: Retain - minor lift over footpath. Existence of bitumen on verge which is a less favourable application for the tree.

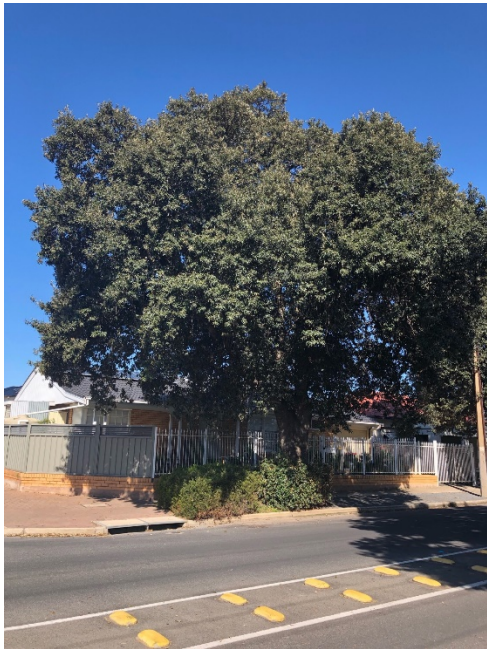
Tree 41

Health: Good

Structure: Good-fair (suckering/recovering from excessive pruning)

ULE: 10-20 years

Risk rating: Low

Recommendation: Retain with some minor dead-wooding to occur.

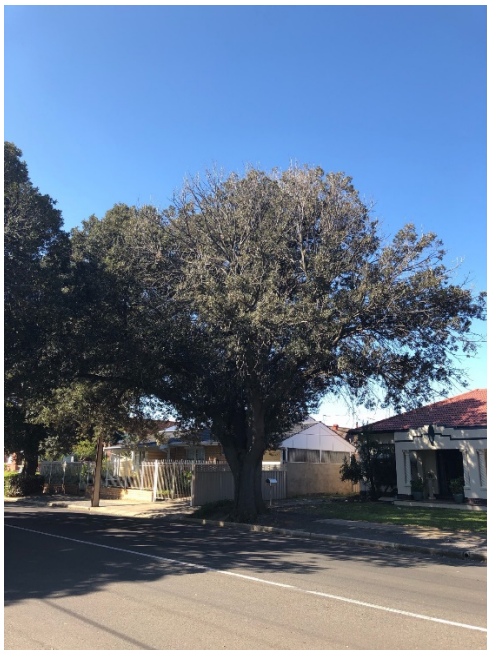
Tree 42

Health: Fair (minor terminal die-back evident)

Structure: Good

ULE: 5-10 years

Risk rating: Low

Recommendation: Retain - dead-wood reduction with minor prune to accommodate stobie pole/service wires. Aim to improve condition with leaky well and monitor health. Review tree health in 12 months.

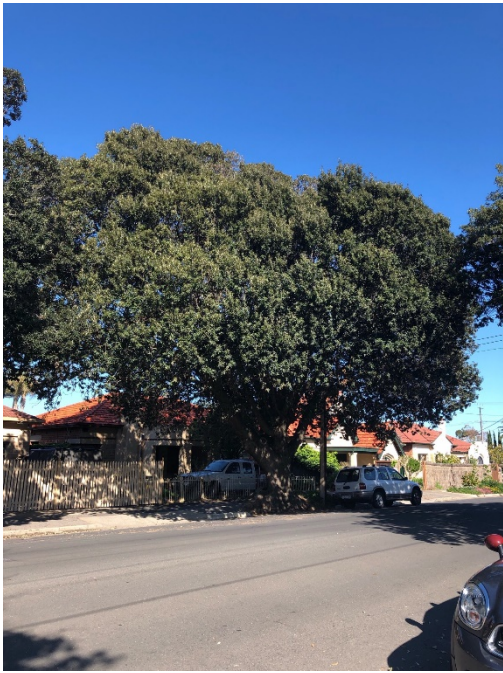
Tree 45

Health: Good

Structure: Good

ULE: 10-20 years

Risk rating: Low

Recommendation: Retain - minor dead-wood and minor lift with tunnelling clearance provided for service wires.
