DEVELOPMENT NO.:	23008590
APPLICANT:	Alberto D'Andrea
ADDRESS:	11 WILLIAMS AV GLENELG EAST SA 5045
NATURE OF DEVELOPMENT:	Demolition of existing residence
ZONING INFORMATION:	<b>Zones:</b> <ul style="list-style-type: none"> <li>Established Neighbourhood</li> </ul> <b>Overlays:</b> <ul style="list-style-type: none"> <li>Airport Building Heights (Regulated)</li> <li>Advertising Near Signalised Intersections</li> <li>Affordable Housing</li> <li>Building Near Airfields</li> <li>Historic Area</li> <li>Heritage Adjacency</li> <li>Prescribed Wells Area</li> <li>Regulated and Significant Tree</li> <li>Stormwater Management</li> <li>Traffic Generating Development</li> <li>Urban Tree Canopy</li> </ul> <b>Technical Numeric Variations (TNVs):</b> <ul style="list-style-type: none"> <li>Minimum Site Area (Minimum site area for a detached dwelling is 500 sqm; semi-detached dwelling is 500 sqm)</li> <li>Maximum Building Height (Levels) (Maximum building height is 1 level)</li> </ul>

#### DETAILED DESCRIPTION OF PROPOSAL:

This application is for the complete demolition of a dwelling at 11 Williams Street Glenelg East. The dwelling is not heritage listed and is not a representative building, but t

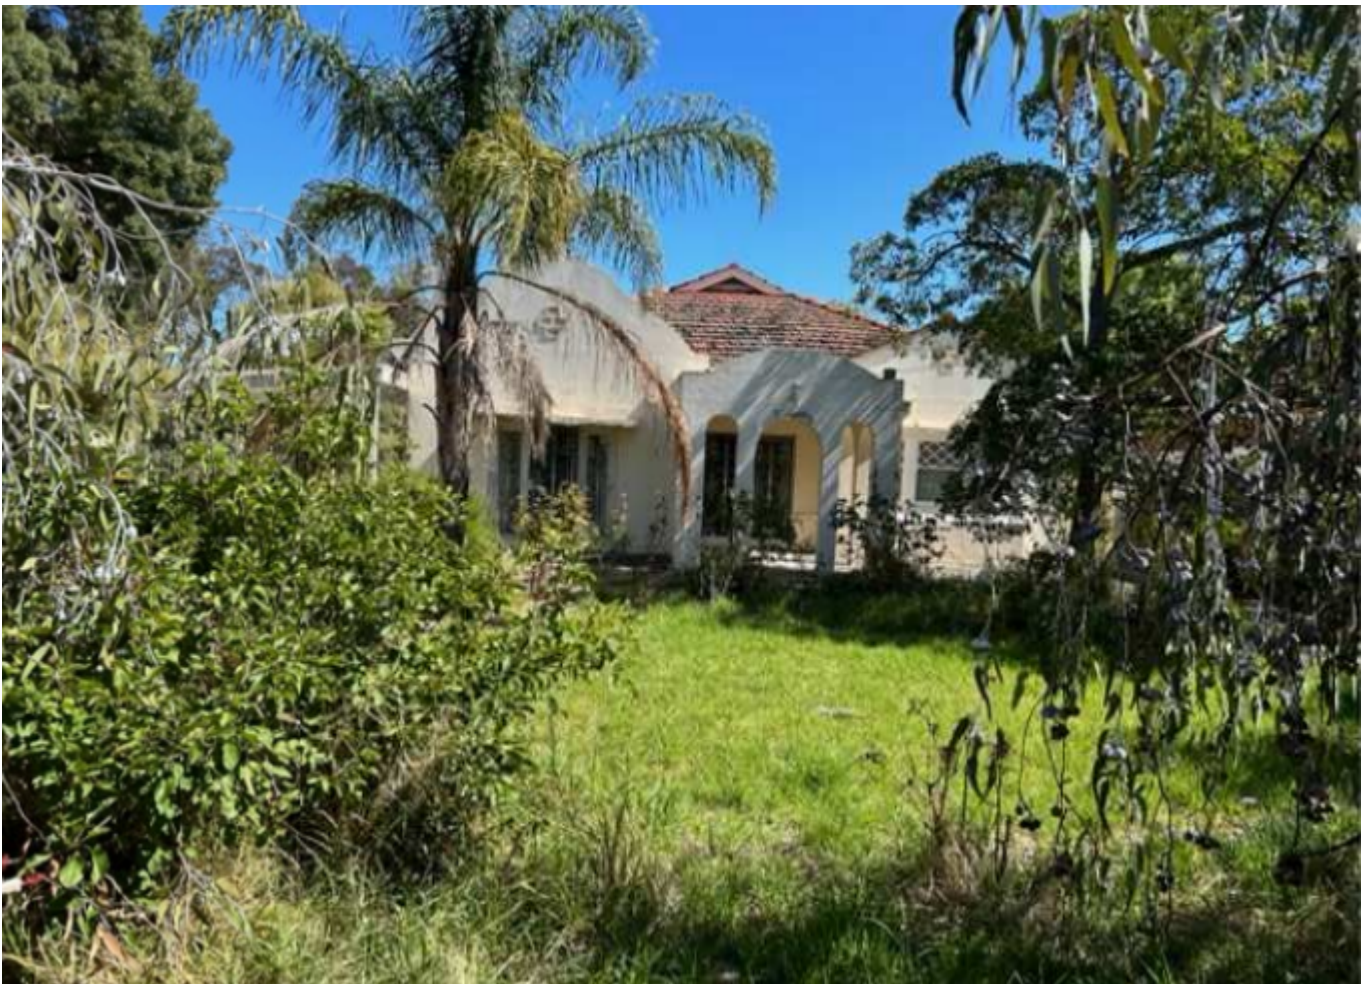
Having inspected the property it is noted that the building is in quite a state of deterioration. Externally there are large cracks and large portion of the cantilever concrete window over hangs have fallen off.

*Photo showing the front façade of the dwelling.*

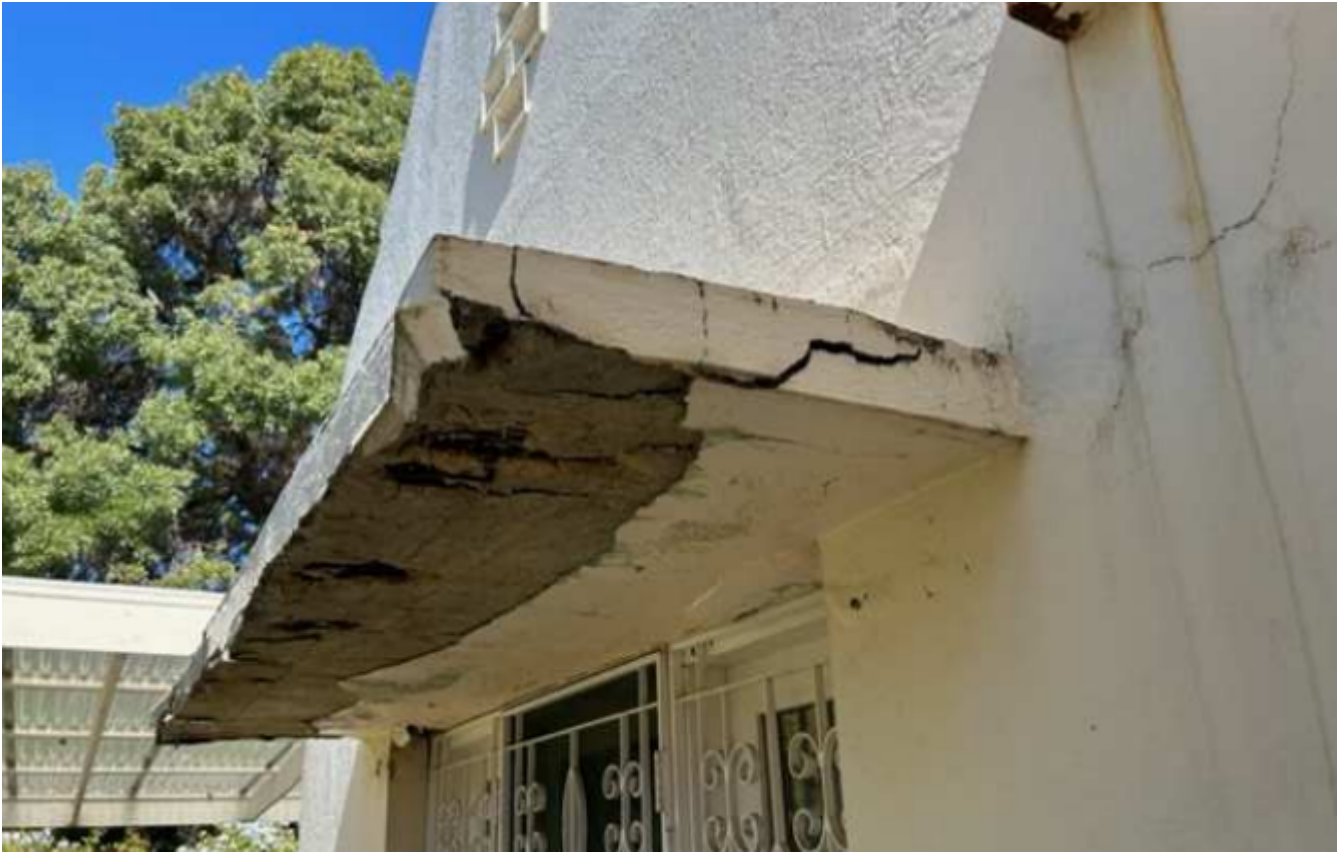
*Photo of the window overhang on the front facade*

Along the front there are some concrete canopies which are spalling ,dropping concrete sections and, in my opinion,they are in such a dangerous state that they should be demolished immediately, before they collapse and injure someone.

Also the cantilever concrete slabs are a severe risk of sudden failure.

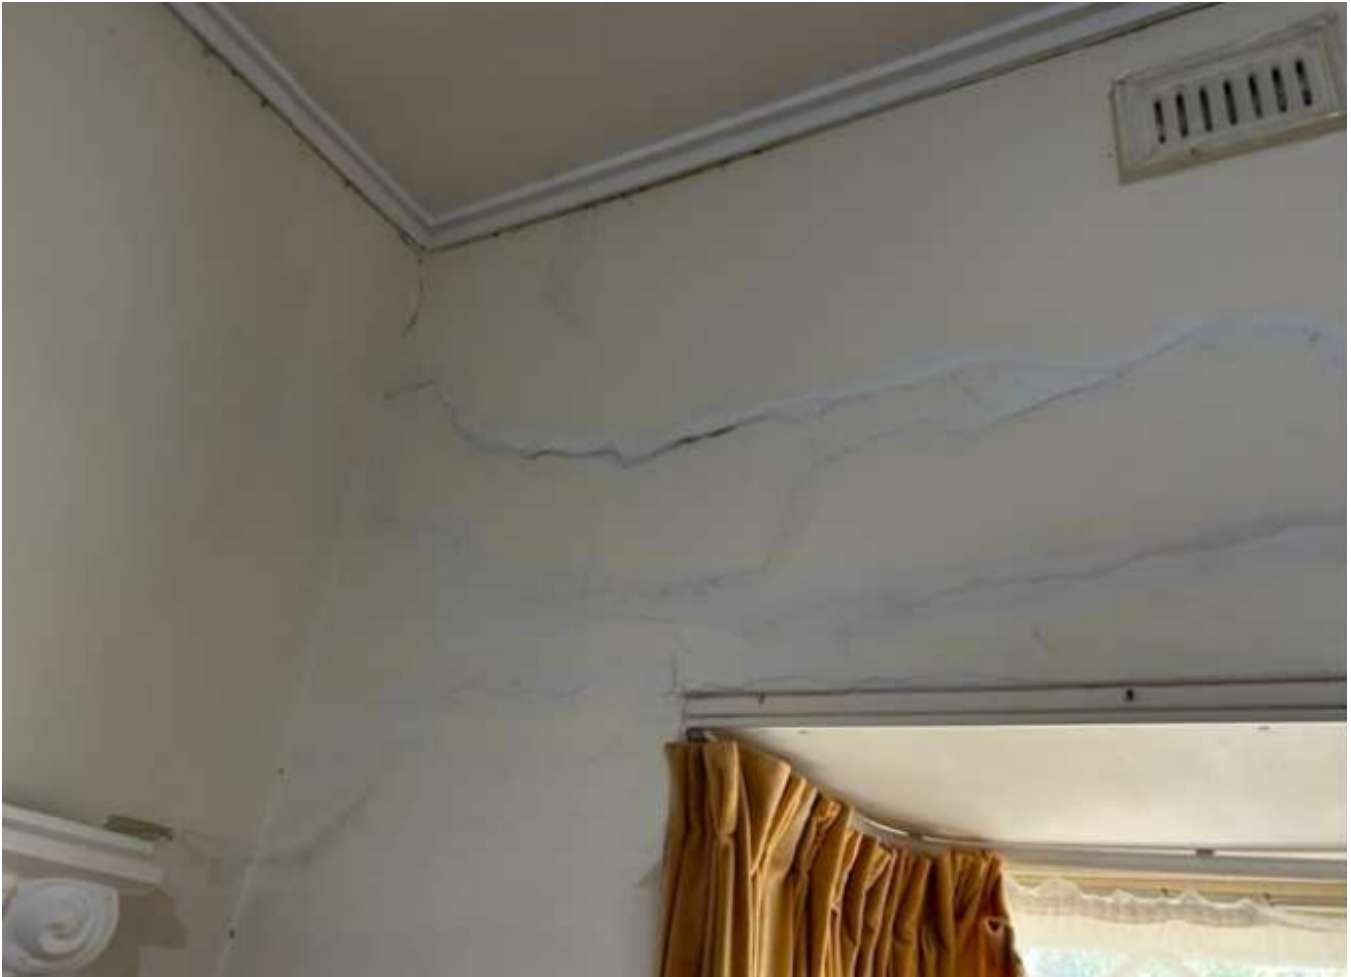
Inside there are large crack throughout the building. Both Engineers have agreed that this is due to the footings having failed.

***Photo showing cracking inside the dwelling***

Generally the cracks in the walls vary between hairline cracks to substantial cracks ( 15mm) and larger.

Generally the wall cracks in the walls on the date of the inspection were 5-15 mm wide and of Damage category 2-4, as described in table C1 of the Residential Slabs and Footings Code ( copy enclosed ).
