Council Report No: 328/22

# **H-CLASS TRAM OPTIONS**

# CONDITION ASSESSMENT AND CONCEPT REPORT

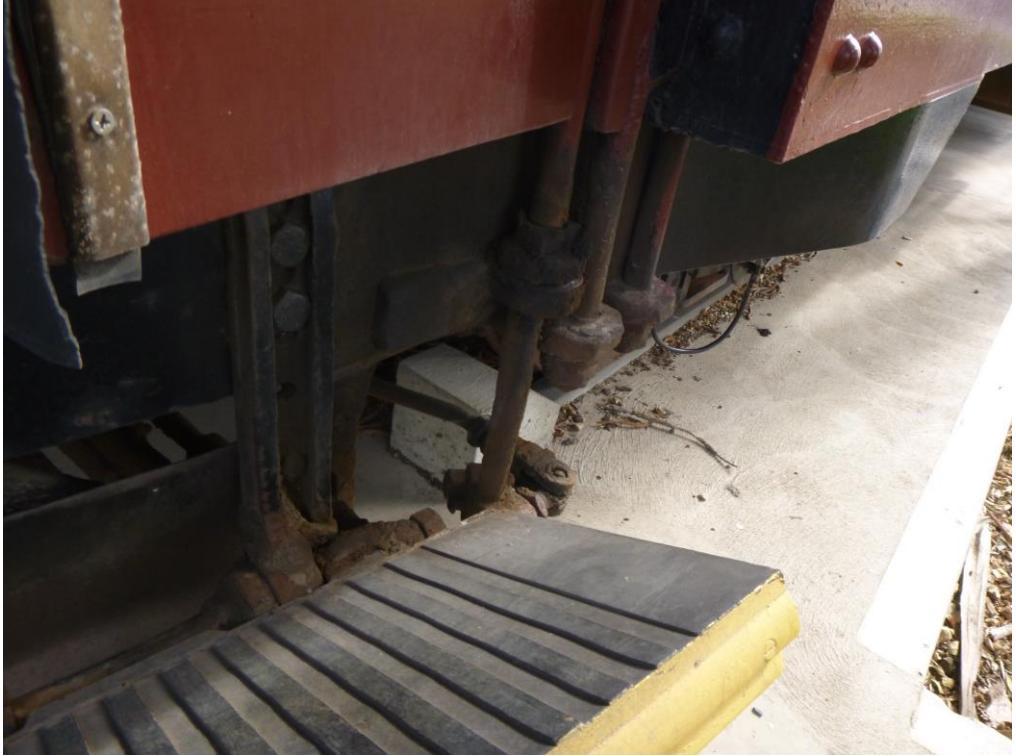
- Moderate corrosion to the hinge assembly for the step. (figure 4)
- Moderate to severe laminated corrosion to the steel plate at each end of the tram. (figure 5)

- Remove the existing entry doors and hinge assembly.
- Inspect the timber framing adjacent the doors, and remove rotted sections of timber. Replace with new hardwood timber and paint to match existing.

- Treat the steelwork for the hinge assembly with new corrosion protection as outlined above.
- Remove the existing rubber door seals and metal strip.
- Install new rubber door seals. Use marine grade stainless steel for the connection strip and fixings.
- If required, replace the entire door and hinge assembly.

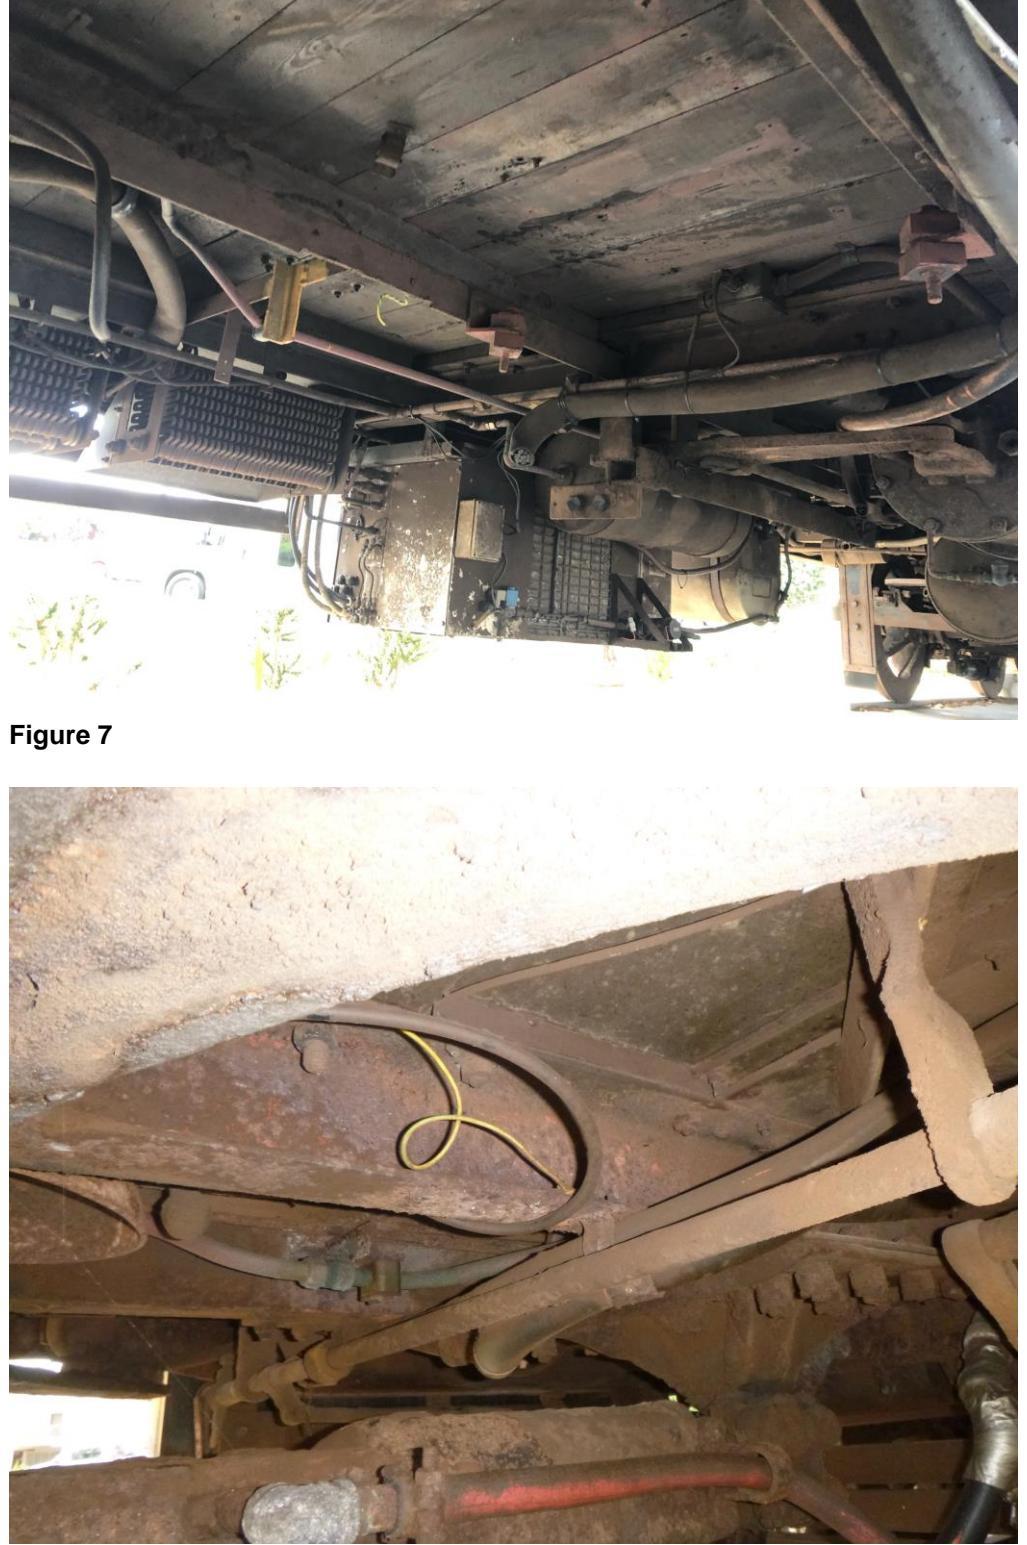
Figure 8

- Moderate to severe corrosion to the undercarriage steel chassis members, which are steel I-beams and equal angles. These critical elements form the structural frame for the tram. (figure 7-9)

- Moderate surface corrosion to the undercarriage componentry generally. (figure 7-9)
- Moderate corrosion to the wheels and bogie assembly. (figure 11)

Treat all exposed external steelwork showing signs of corrosion. All corrosion protection shall be applied in accordance to manufacturer's specifications. Corrosion protection applied as follows:

- Wash and power wire brush or grit blast (to class 2.5 surface to AS1627), to a bright steel finish.
- Assess the severity of the corrosion to the undercarriage structural steel (chassis), by measuring the wall thickness of the steel using an ultrasonic thickness measurer in at least three locations per member.

**Note:** The urgency of the repairs to the undercarriage structural steel (chassis) depends on the severity of the corrosion. Contact our office for further assessment after the above has been undertaken. Steelwork with minor corrosion may not require urgent maintenance. Steelwork with severe corrosion and section loss may need to be removed and replaced with a new member of equal size and grade (this has not been allowed for in the estimated cost).

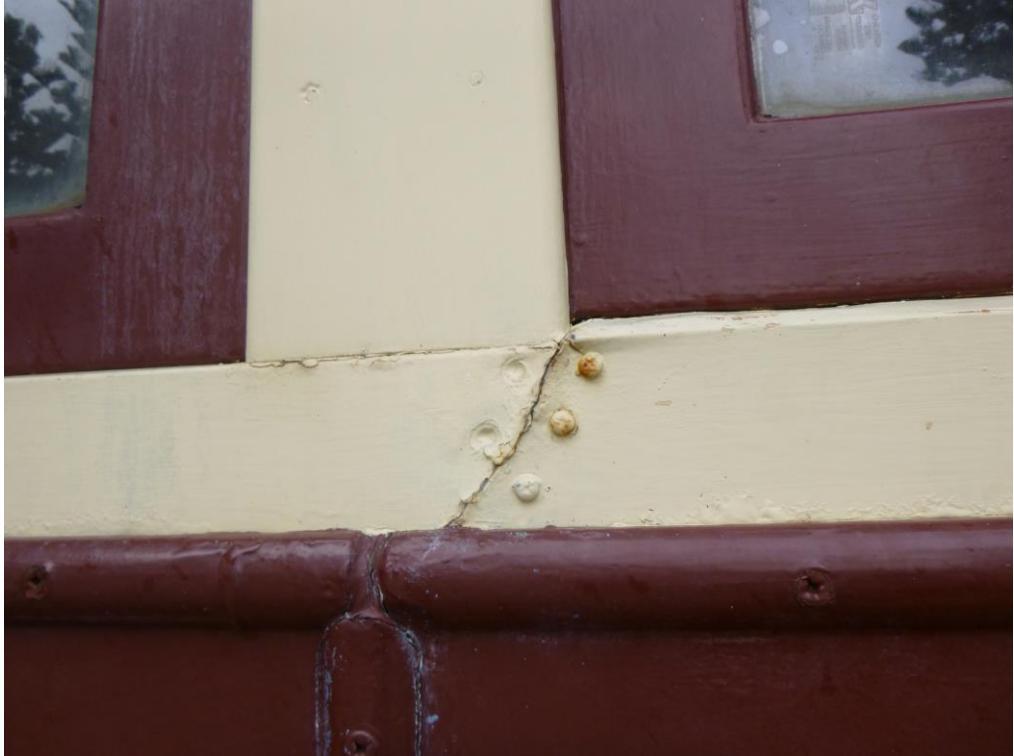
Figure 10

- Corrosion to the screw fixings for the timber around the windows. Appears to be some minor splitting and timber rot present around the fixings in some cases. (figure 10)

Corrosion to the steel screw fixings for the external timber window framing is not an urgent structural problem. However, as the screws corrode, they expand and may promote further splitting; which allows moisture to penetrate into the timber and accelerating timber rot. All corroded steel fixings should be removed and replaced with marine grade stainless steel fixings, and any gaps or splits in the timber joints should be sealed to prevent moisture penetration.

- Remove existing corroded steel screw fixings (securing the external timbers)
- Replace with marine grade stainless steel screw fixings (countersunk)
- Fill any gaps or splits in the timber as follows:
  - Clean and prepare gap to be dust free.
  - Fill and seal gap with Parchem Nitoseal MS250 sealant.
- Provide externally rated timber filler over the fixings and re-paint timber to match existing

Note: If any rotted timber is found following removal of fixings, replace the rotted section with H3 treated hardwood, size to match existing, paint to match existing.

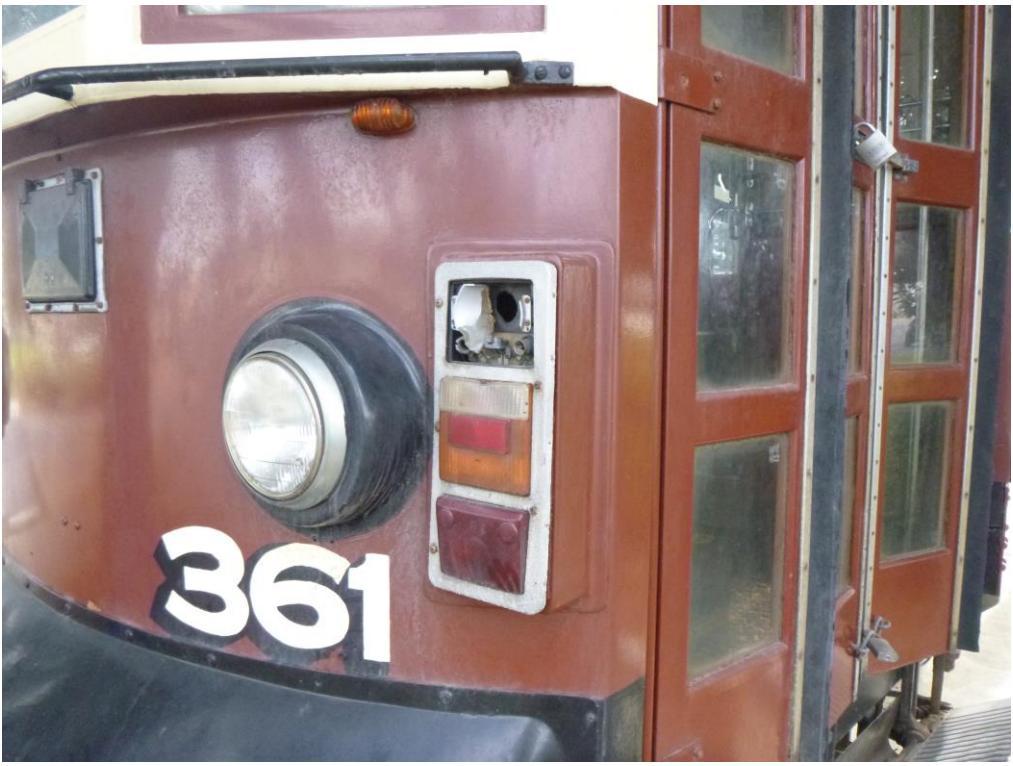
Figure 12

- Broken light at the eastern end of the tram. (figure 12)
- The roof of the tram appeared in reasonable condition, with minimal signs of paint failure or corrosion. (figure 13)

- Replace the light at the end of the tram
- Reconnect the steel roof fascia plate at the end of the tram.

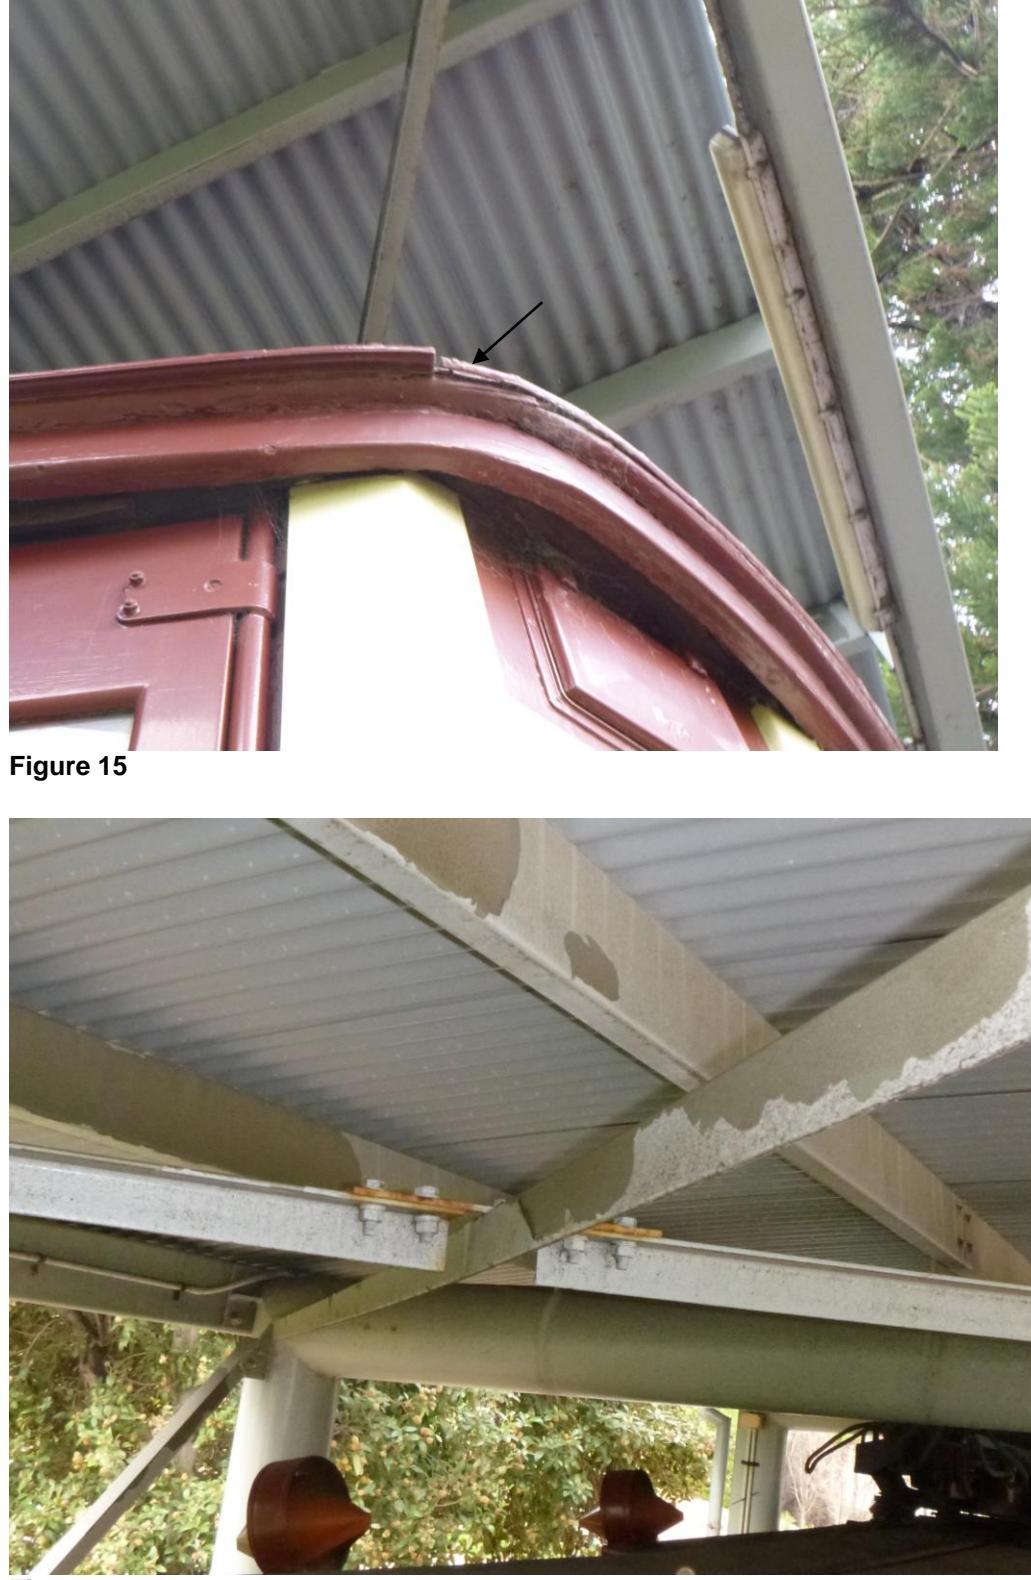
Figure 16

- Although beyond the scope of this report, it was noted that the paint system for the steel canopy structure above the tram has failed, and corrosion has developed in some locations. (figure 16)
