# **BARTON GULLY MASTERPLAN**

**FEBRUARY 2021**

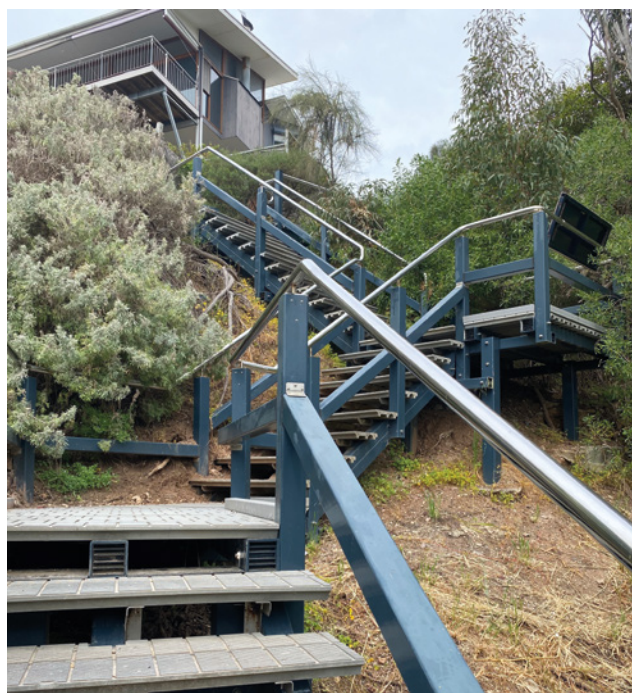
Figure 2. Composite fibre and recycled plastic staircase.

Informal tracks have steadily been replaced by Council with more formal trails and steps in steep areas to encourage appropriate use and reduce erosion. An example of this is the composite fibre and recycled plastic staircase and boardwalk installed by Council in 2012. The boardwalk and staircase have an expected life of over 40 years and will require little maintenance. In addition, two log benches have been installed in the eastern and southern areas of the gully.

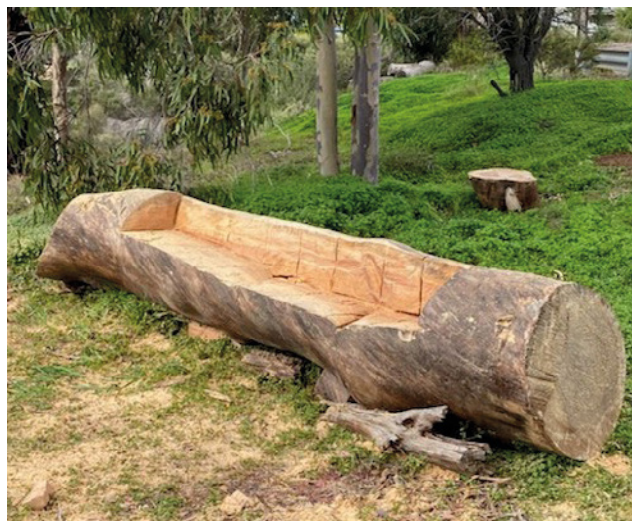
Figure 3. Log bench.

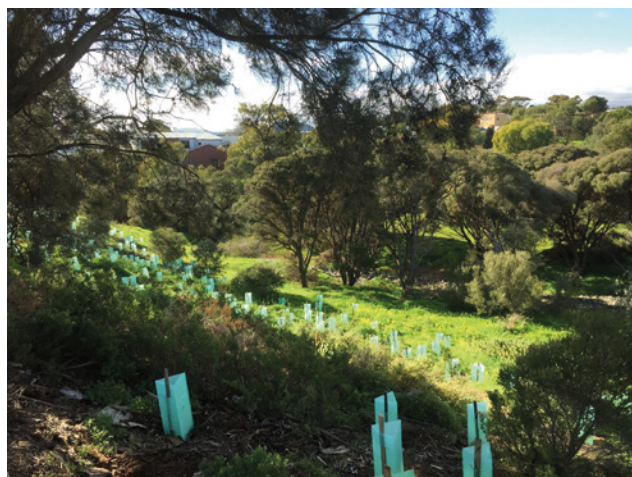
Figure 4. Barton Gully revegetation.

Additional revegetation is planned by Council for the gully consistent with this masterplan's recommendations.

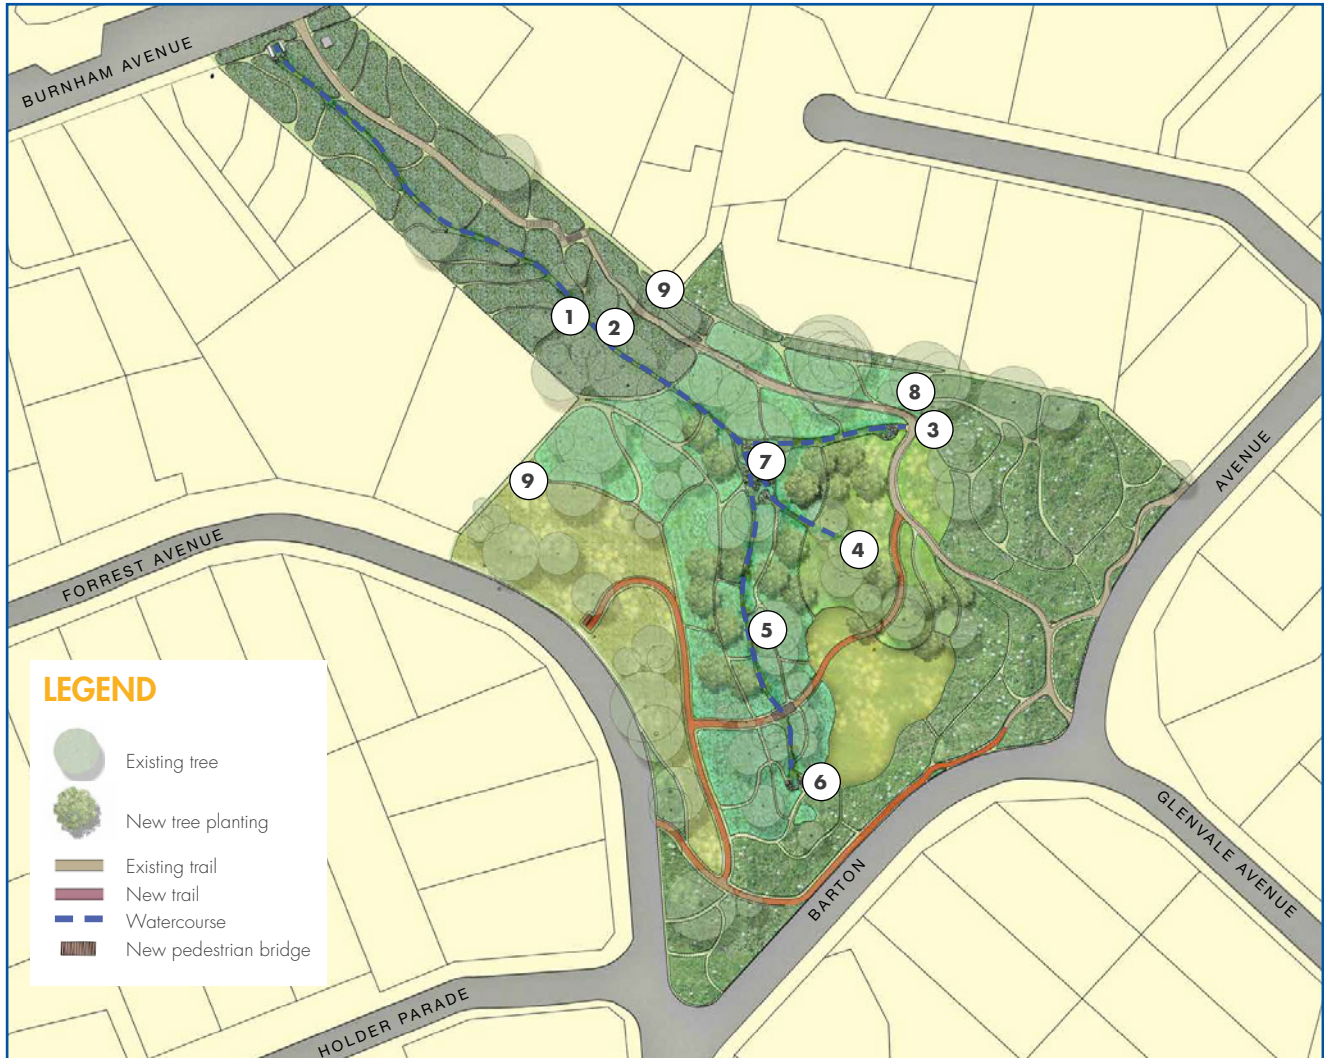
Figure 5. Opportunities and constraints.

1. Small erosion head progressing upstream of larger bed drop near the stairs. Area covered in kikuyu and difficult to see. Minor erosion protection works required

2. Stormwater outlet from the road. Poor scour protection with some undercutting. Stabilise outlet with rock armouring to tie in with remediation of erosion head

3. Small flow path from pipe outlet. Crosses walking track with a small pipe. Upgrade the culvert beneath the track to reduce flow frequency across the track

4. Small gully but no identified inflow point. Substantial rock armouring with minimal vegetation. Rock armouring unnecessary and could be removed and used locally within the reserve

5. Rock-armoured channel. Excessive rock extent with most flows likely to be along the soil/rock interface. Barren sight line up gully with minimal revegetation within channel or adjacent banks. Rock weirs present but poorly formed and would be outflanked if flows high enough to flow across rock surface. Recommend to reprofile the rock-armoured section to retain more stormwater and improve vegetation cover

6. Sediment removal around stormwater outlet. Increase grade directly at outlet to avoid ongoing accumulation that may block pipe opening
7. Gully water retention

8. Existing gully trail link to foreshore. Limited access with current trail width and steep embankments
9. Unstable steep grades. Increase stabilisation through revegetation

The various opportunities and constraints presented by the site have been evaluated in terms of stormwater management, landscape and vegetation. A summary of the evaluation is provided below, with the locations of the opportunities and constraints shown in the attached plan (refer to Figure 5). It is also important, given the cultural significance of the site, that any proposed works carried out in the area be planned in consultation with Kurna representatives. A review of Barton Gully was undertaken with Kurna representatives in September 2019.

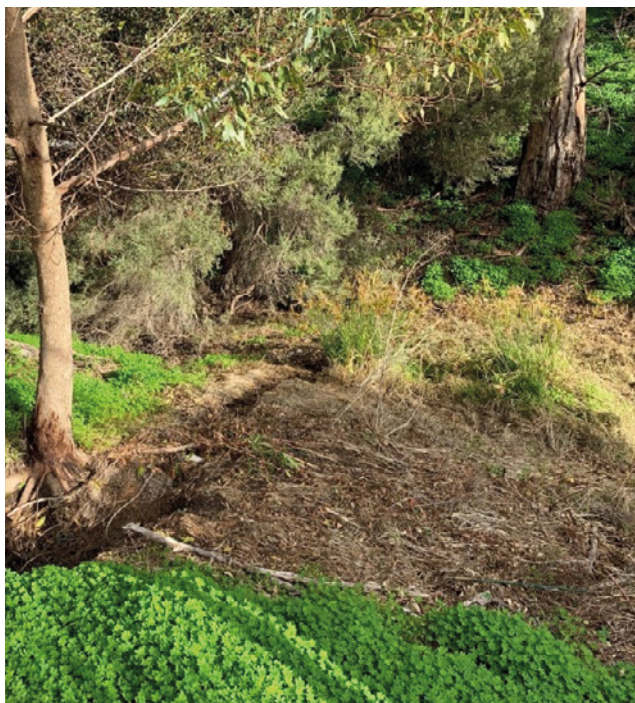
Figure 6. Erosion caused by stormwater flows.

Barton Gully is quite steep in places and therefore when it rains, water flows quickly through the gully, causing erosion and carrying sediment out of the gully.

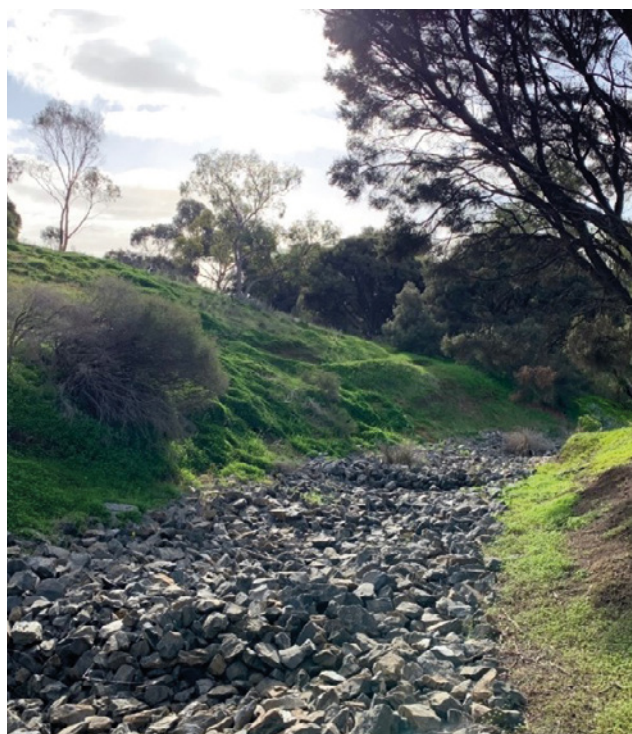
Significant rock-lining of watercourses has been completed and, whilst preventing erosion, it is considered excessive, leading to reduced revegetation of the watercourses (refer Figure 7). This rock lining can be improved to reduce the visual extent of the rock work, and allow planting in between rocks to improve water quality, assist in slowing the water and reduce the heat load created by the rocks. In addition, the rock weirs can be improved to create local ephemeral ponds (temporary ponds that slow the water down) for vegetation and to capture silt.

Figure 7. Excessive watercourse rock lining.

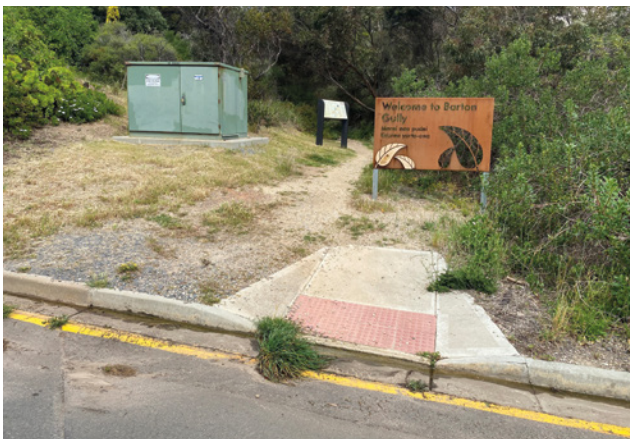
Figure 8. Existing signage at Burnham Road entry.

The existing educational signage could be continued throughout the site to coincide with the restoration and revegetation works.

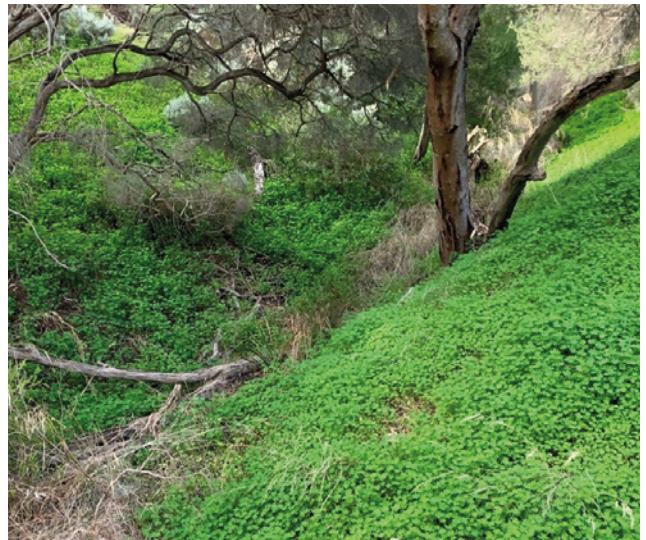
Figure 9. Steeply sloped section of the gully.

The site has one patch of remnant native vegetation, and areas where native plants have been re-established. The sloping site does present challenges for revegetation because of restricted access in some areas. Some of the replantings used species that are not local or suitable to the gully environment and these should be gradually replaced with appropriate species. This is especially the case with some of the larger trees that line the narrow path to the coast.

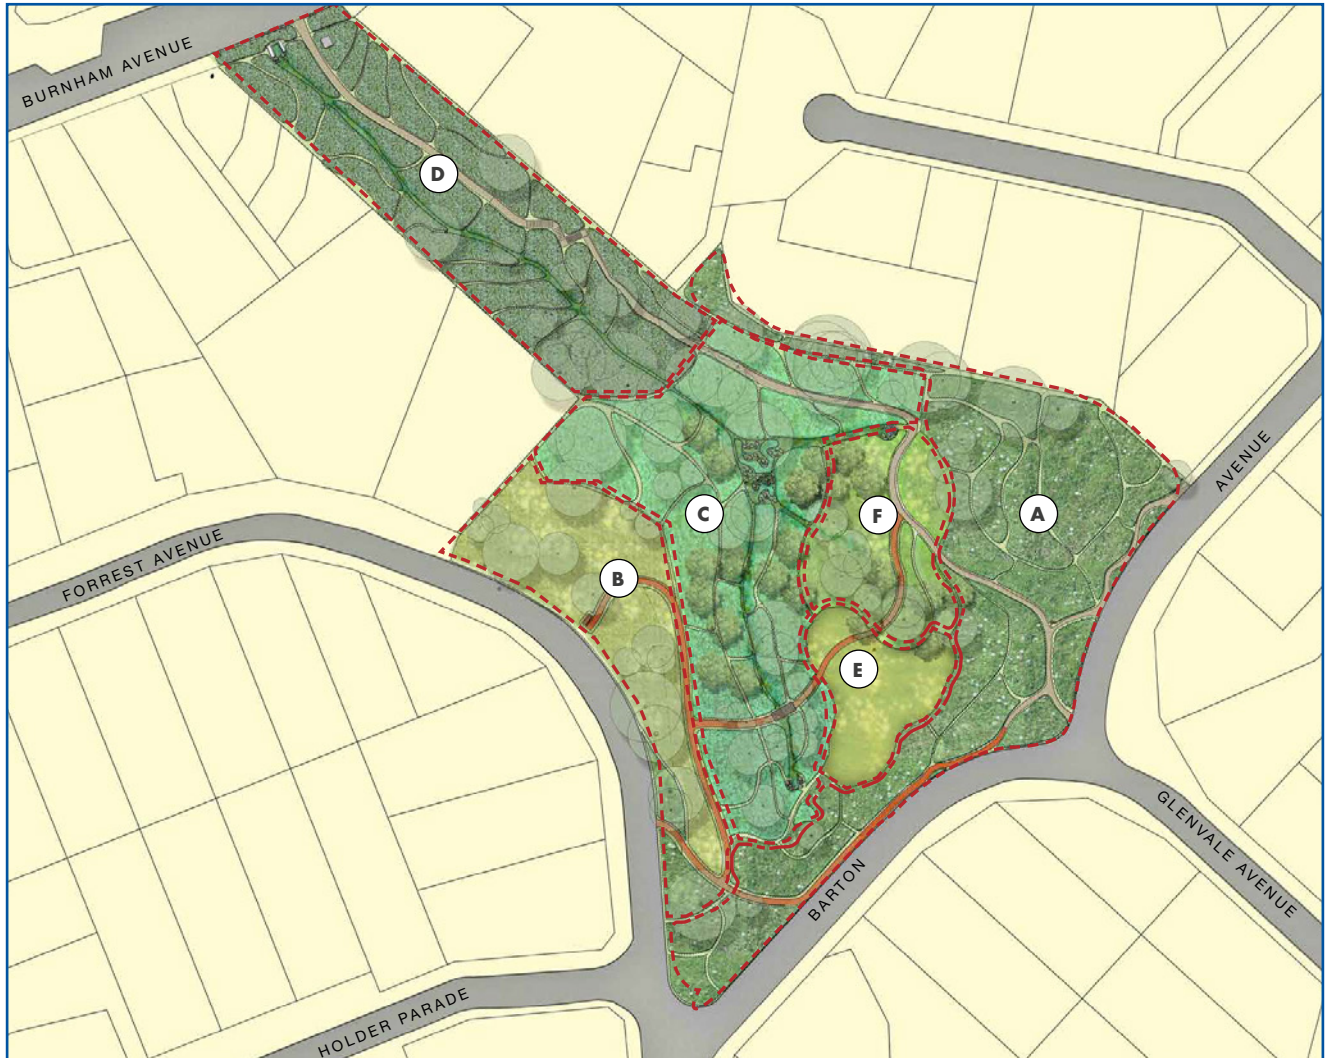
Figure 10. Vegetation zones.

### ZONE A – REVEGETATION AREA

- Control of grassy weeds and soursob
- Remove non-indigenous shrub plantings
- Consider further plantings of native sedge species in the moist drainage line in the northern section

### ZONE B – NORTH-FACING SLOPE ON SOUTHERN SIDE OF GULLY

- Over time remove non-native plantings and replace with scattered *Eucalyptus porosa* and *Allocasuarina verticillata*
- Consider widely spaced plantings of *Pittosporum angustifolium* and *Acacia acinacea*
- Sensitive weed control to promote recruitment of native understorey species already present in the area

### ZONE C – GULLY DRAINAGE LINE

- Establish natural logs across the slope (away from walking trails)
- Revegetation of lilies, forbs and low and medium shrubs in open areas
- Assess potential for native sedges (e.g. *Cyperus* spp., *Juncus* spp.) along edges of drainage line.
- Control *Melaleuca nesophila*

#### **ZONE D – LOWER WATERCOURSE**

- Control of high threat woody weeds
- Control of weeds along creekline with concurrent revegetation
- Removal of some of the native non-indigenous species that have a propensity to spread
- Control of grassy weeds and soursob
- Revegetation on steep slopes to help manage erosion, trial use of *Myoporum parvifolium* in these areas

#### **ZONE E – OPEN GRASSLAND AREA**

- Careful revegetation (avoid disturbing native grasses) to create a very open woodland habitat
- Encourage grassland species by periodic brush cutting

#### **ZONE F – OPEN GRASSLAND AREA**

- Monitor survival of current revegetation, and infill as necessary (avoiding disturbing native grasses) to create an open woodland habitat
- Encourage grassland species by periodic brush cutting

Barton Gully has been divided into six distinct vegetation zones, based on the existing vegetation and landscape features. These vegetation zones will be used to assist with revegetation and weed control, which will be guided by a detailed biodiversity action plan. The following vegetation zones are shown in Figure 10:

- Zone A: Revegetation area
- Zone B: North-facing slope on southern side of gully
- Zone C: Gully drainage line
- Zone D: Lower watercourse
- Zone E: Open space area
- Zone F: Open grassland area

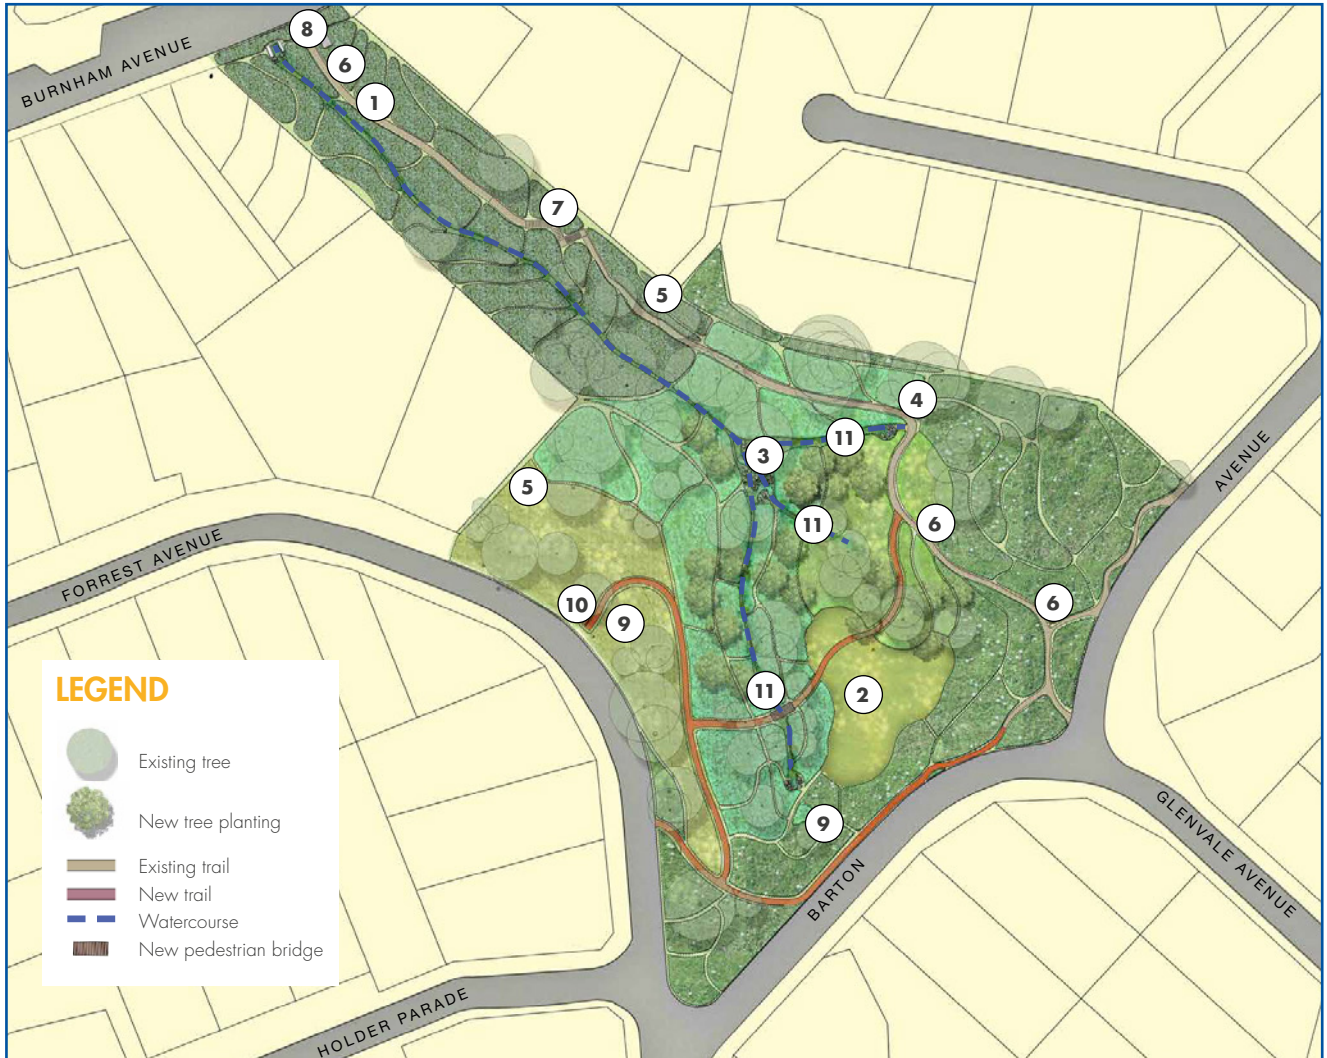
Figure 11. Barton Gully masterplan recommendations.

| 1. Existing trail linking foreshore with gully | 5. Steep grades revegetated and stabilised | 10. Install new log seat at viewpoint at end of new path |
| 2. Open grassed area | 6. Existing signage | 11. Revegetation to slow water and mitigate erosion within channel |
| 3. Potential water retention opportunity and <i>Oxalis perennans</i> propagation site | 7. Stabilise embankments | |
| 4. Existing trail widened and benched into embankment to improve access | 8. Existing trail link | |
| | 9. Limit tree planting to maintain residents views | |

The recommendations outlined in this section provide direction to enhance the existing biodiversity and improve access for the community to enjoy the natural environment provided by Barton Gully. Figure 11 shows the location for each of the recommendations.

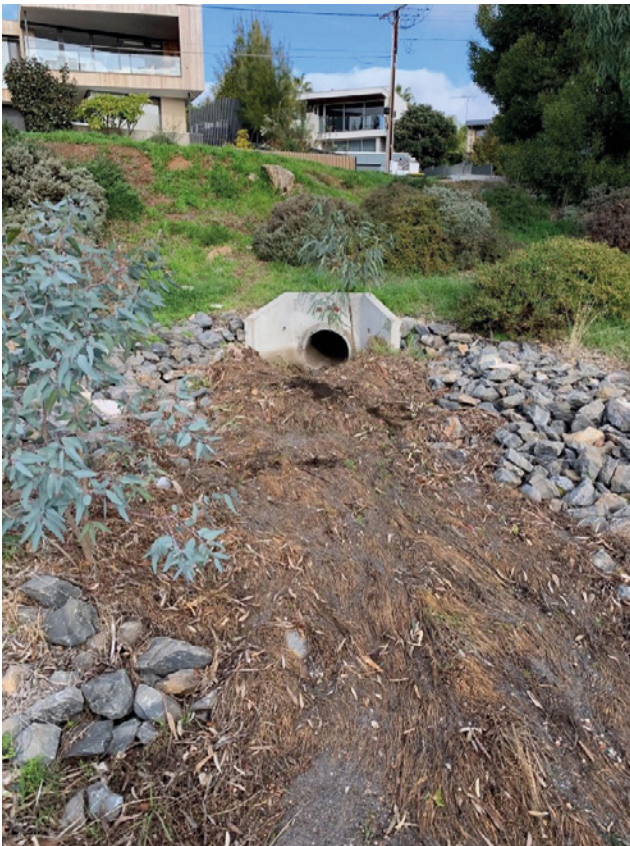
The inlet has recently been upgraded to minimise erosion. The placement of informal stepping stones across the riffle will improve the safety for people crossing at that location.

Figure 12. Barton Road stormwater discharge into Barton Gully.

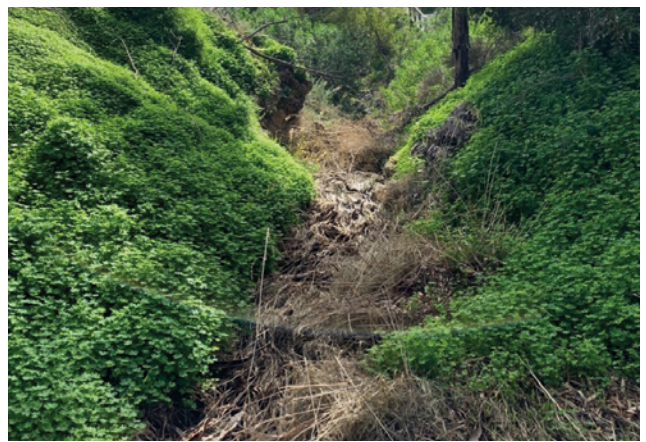
The main drainage lines through the upstream gully have been rock-armoured and are in good condition. Some improvement to create check-dams and planting pockets is recommended. The downstream gully shows signs of erosion at several locations, and it is recommended that these areas be remediated, and erosion protection measures deployed to minimise any future or ongoing erosion. The following solutions will be considered for erosion protection, including:

- Rock lining along incised sections of the gully invert
- Rock “leaky” check-dams
- Turf reinforcement mat with vegetation.

Figure 13. Erosion in Barton Gully.
