Welcome to Gilbertson Gully

GILBERTSON GULLY MASTERPLAN

FEBRUARY 2021

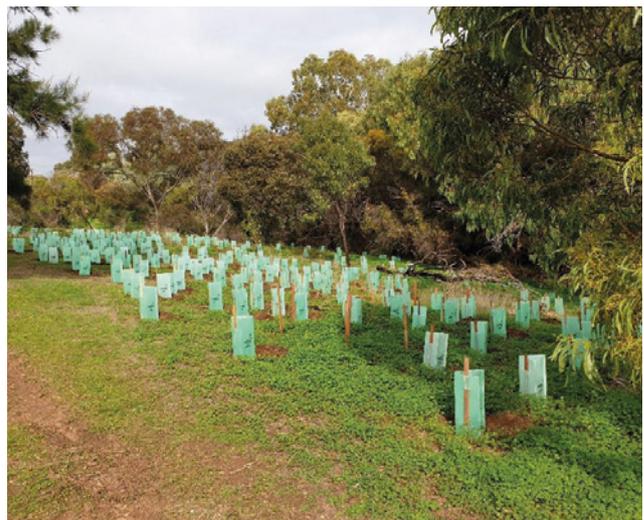
Figure 3. Winter 2020 revegetation plantings.

Most recently, 4,155 new plants, including local native grasses, groundcovers, wildflowers, climbers, shrubs and small trees, were planted in the winter of 2020. This recent revegetation of the gully is consistent with this masterplan's recommendations.

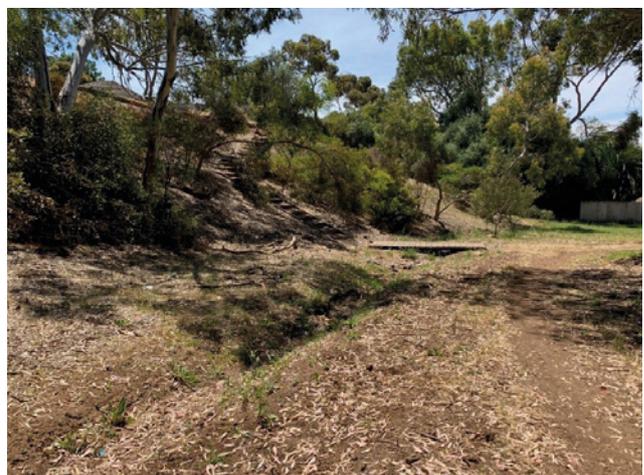
Figure 4. Makeshift bridge over creek line.

The local community has installed makeshift bridges over the creek in some locations.

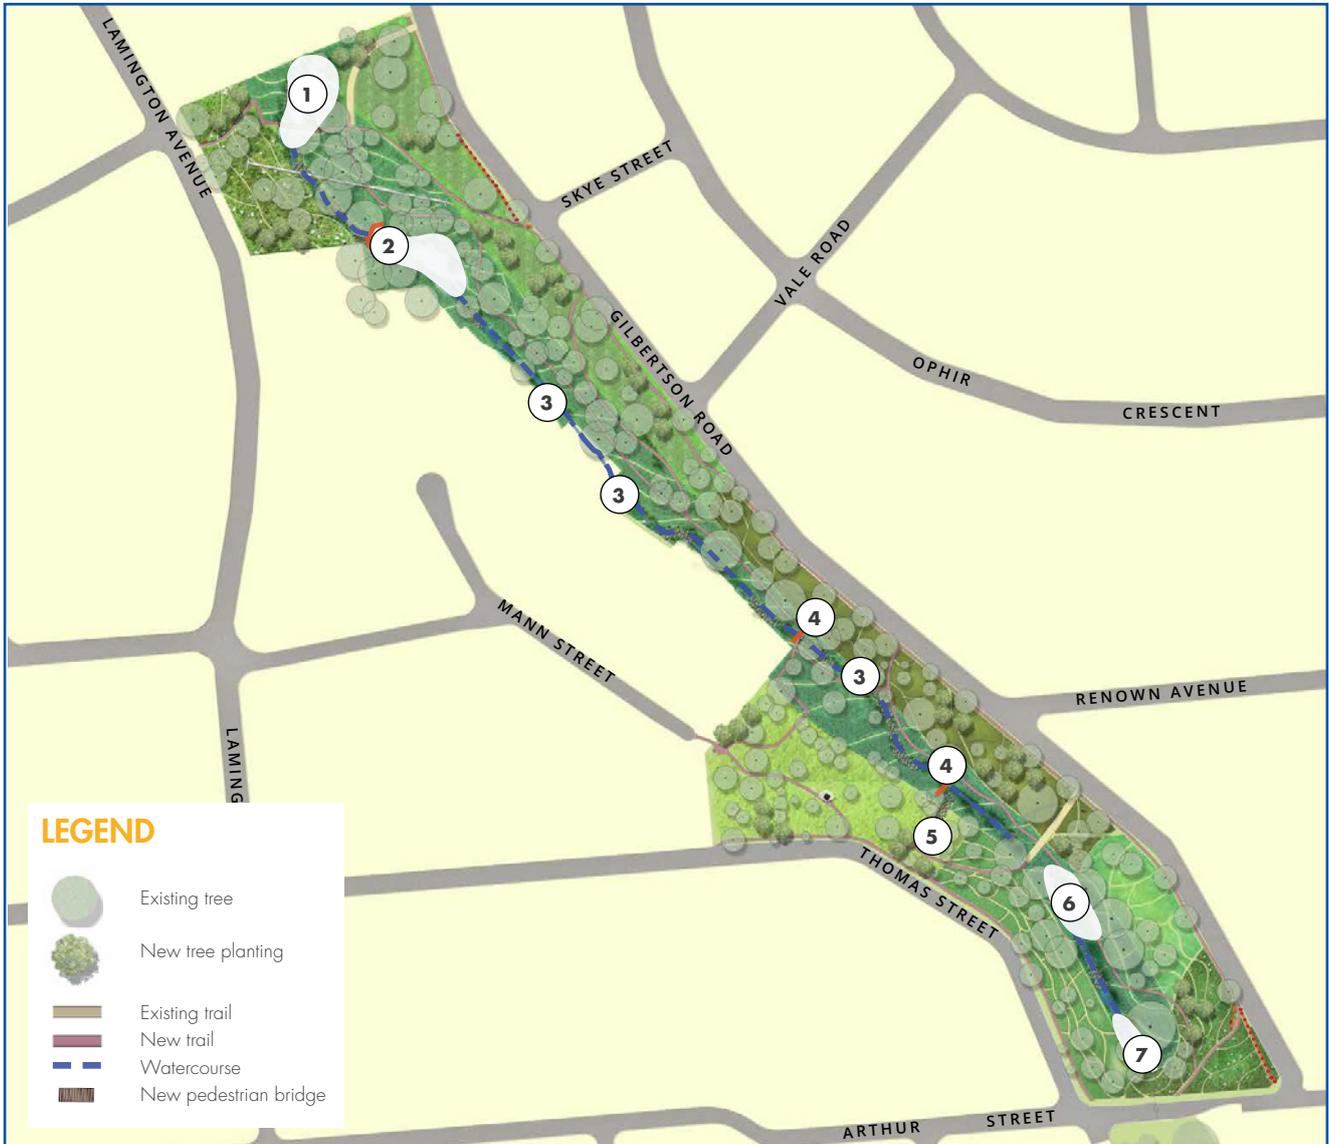
Figure 5. Opportunities and constraints.

1. Potential basin for increased infiltration and to be planted to improve water quality. Formalise outlet structure to downstream property
2. Modify basin outlet structure to formalise the overflow weir and bund adjustment to the weir to reduce outflanking. Basins to increase infiltration and to be planted to improve water quality
3. Reprofile channel and construct small rock chutes. Lay back and revegetate banks
4. Pool and riffle system at crossing locations
5. Stabilise stormwater outlet with level spreader
6. Frequent blockage of heawall. Construct screening arrangement/sediment trap upstream of inlet headwall to minimise frequency of blockage
7. Sediment accumulation between headwall and top of rock chute. May lead to outflanking of rock chute. Desilting and construction of sediment trap to be considered

The various opportunities and constraints presented by the site have been evaluated in terms of stormwater management, landscape and vegetation. A summary of the evaluation is provided below, with the locations of the opportunities and constraints shown in the attached plan (refer to Figure 5). A review of Gilbertson Gully was undertaken with Kaurua representatives in September 2019.

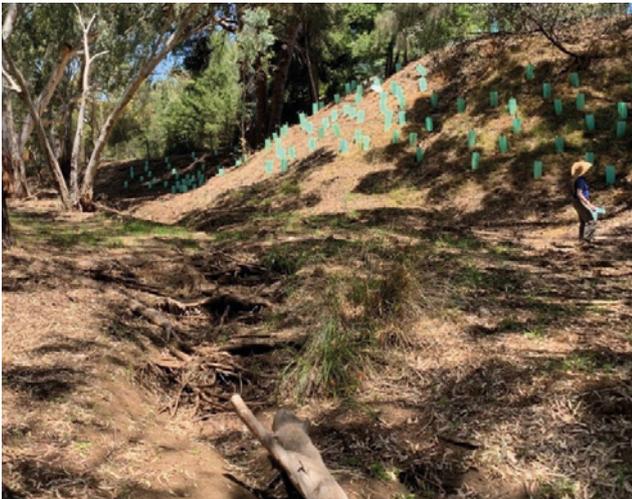
Figure 6. Watercourse erosion.

Gilbertson Gully is quite steep in places and therefore, when it rains, water flows quickly through the gully, causing erosion and carrying sediment out of the gully.

There is an opportunity to improve the management of stormwater within the gully by implementing measures that slow the speed of water flow, reduce erosion and improve the quality of the water before it leaves the gully. These measures include rock stabilisation, and revegetation of eroded sections of the watercourse, with native species as well as reshaping of embankments to provide increased bank stability. Refer to Appendix A for further information on the identified stormwater improvements.

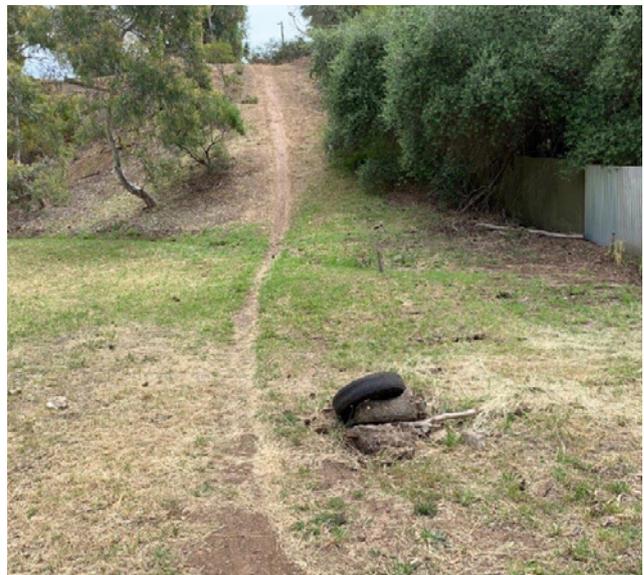
Figure 7. Informal entry trail at the downstream end of the gully.

There is the opportunity to formalise existing sections of the trail network around key entry points into the gully. This is particularly important along the steeper sections of the gully, where informal paths have contributed to erosion. New trail alignments and linkages can be created that will allow safer access for visitors and provide a sustainable trail network that reduces annual maintenance.

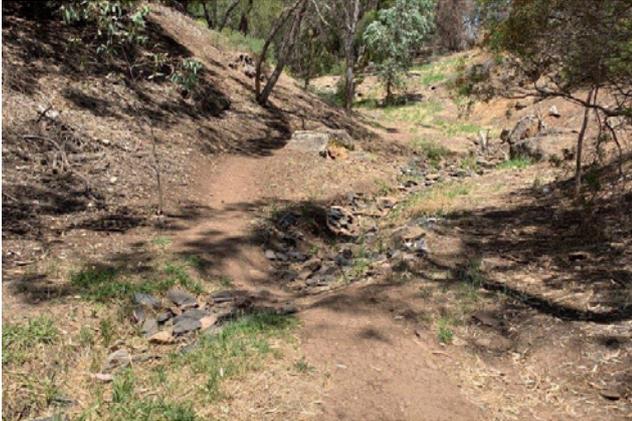
Figure 8. Existing creek crossing point.

Creation of paths that follow the natural contours of the sloping site, together with a trail along the creekline, will also improve access and provide opportunities for views across the site. Formal crossing points, such as pedestrian footbridges across the watercourse, will allow visitors to gain improved visibility and maintain a higher level of safety.

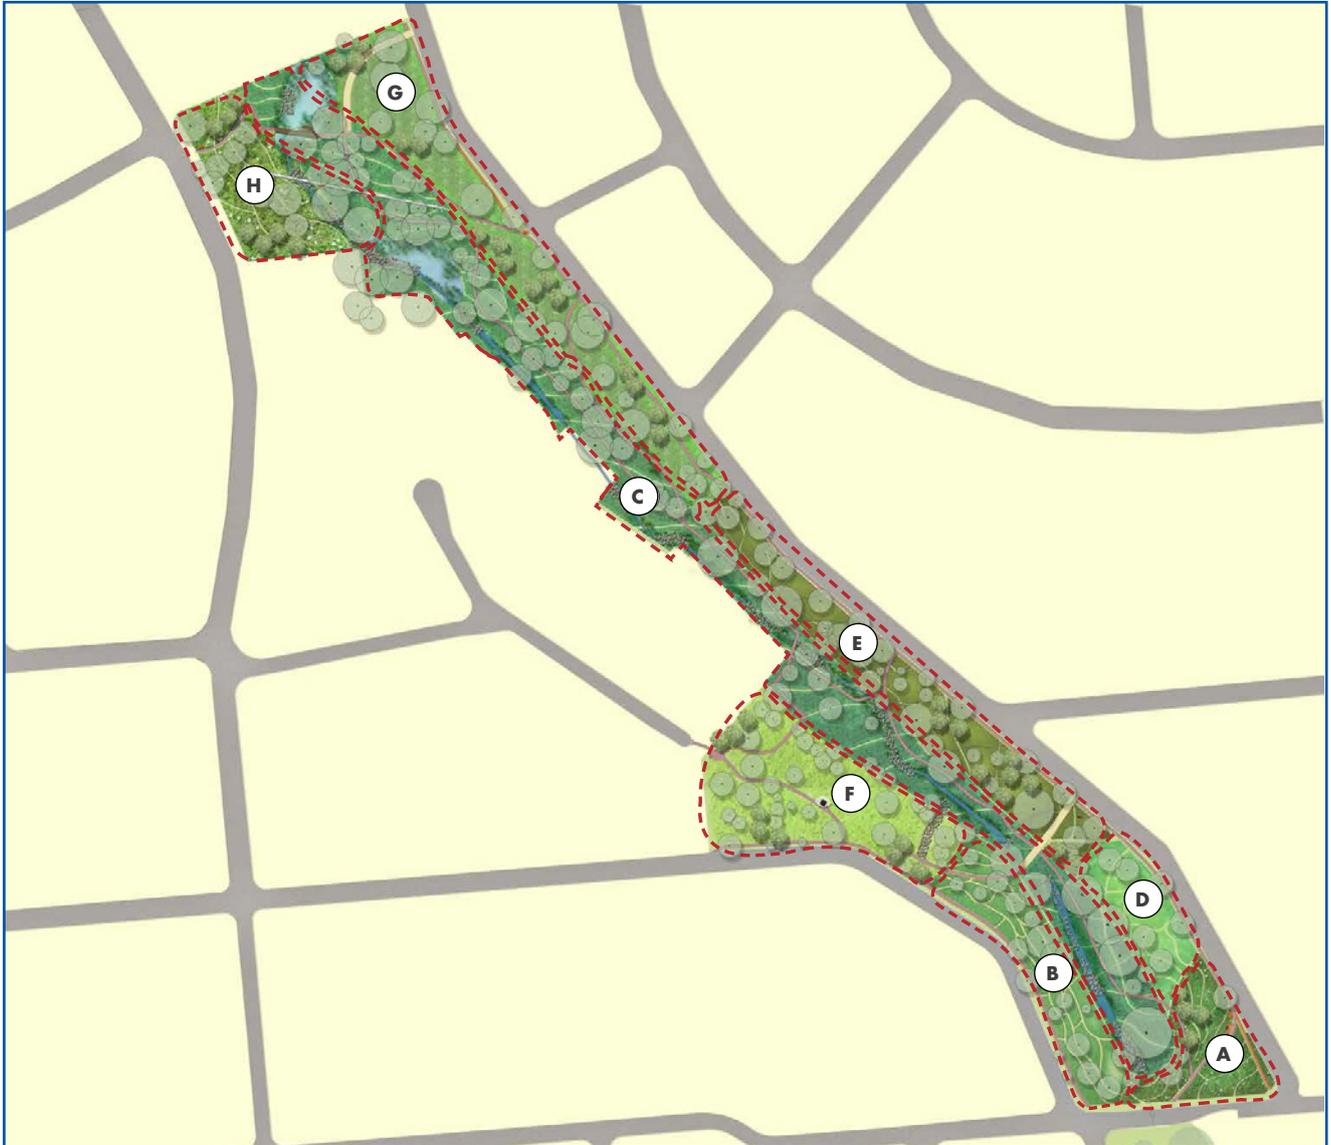
Figure 9. Vegetation zones.

ZONE A – REVEGETATION SITE AT HIGHLY VISIBLE ROAD CORNER

Planting will provide an entry statement into the gully.

- Weed control followed by revegetation with higher density to enhance existing revegetation and prevent more weeds
- Monitor success of mulching

ZONE B - EAST-FACING EMBANKMENT ABOVE THE WATERCOURSE

- Monitor revegetation for success and infill as required
- Review treatments for soursob (*Oxalis pes-caprae*) and implement as appropriate
- Christmas bush is especially recommended for this zone. It provides valuable food for nectar-feeding insects in early summer

ZONE C – WATERCOURSE (IDENTIFIED AS A SINGLE UNIT)

- Reduce biomass of soursobs
- Staged removal of non-indigenous shrubs that are spreading (*Melaleuca spp.*, *Acacia saligna*), and replace with indigenous alternatives
- Control priority woody weeds: *Olea europaea*, *Fraxinus angustifolia*, *Arundo donax*
- Control weed grasses such as kikuyu
- To further stabilise the watercourse after the stormwater works, mass plantings of *Carex bichenoviana*, *Cyperus gymnocaulos*, *C. vaginatus* and *Juncus pallidus* are recommended

ZONE D – WEST FACING EMBANKMENT ABOVE THE WATERCOURSE

- Monitor revegetation and infill as required, aiming for an open woodland with a grass and lily understorey
- Staged removal of non-indigenous species that are spreading (*Melaleuca nesophila*), replacing with indigenous alternatives
- Review treatments for soursob (*Oxalis pes-caprae*) and implement as appropriate

ZONE E – ANOTHER SECTION OF THE WEST-FACING EMBANKMENT

- Revegetate, aiming for an open woodland with a grass and lily understorey
- Staged removal of non-indigenous species that are spreading (*Melaleuca nesophila*), replacing with indigenous alternatives
- Control the *Fumaria sp.*
- Review treatments for soursob (*Oxalis pes-caprae*) and implement as appropriate

ZONE F – ROCKY OUTCROP AND THE TOP OF THE RISE

- Remnant are of native pine, native apricot and mallee box with good density of native grasses, sedges and lilies
- Control *Acacia saligna*
- Consider sensitive bushcare weeding approach in this area

ZONE G – RIDGETOP ON THE EASTERN SIDE OF THE GULLY

- Remnant vegetation in moderate to good condition
- Monitor revegetation and infill as required, aiming for an open woodland with a grass and lily understorey
- Scattered small tree and shrub plantings
- Consider sensitive bushcare weeding approach around the large eucalypt in the northern corner
- Control and staged removal of non-indigenous species that are spreading (*Melaleuca nesophila*, *Acacia iteaphylla*)
- Control high threat woody weeds (olive and buckthorn)

ZONE H – FLAT AREA AT NORTH-WESTERN END

- A dry area with overstorey of introduced species and depauperate in structural layers
- Revegetate with the aim of achieving an open woodland with a grass and lily understorey

Gilbertson Gully has been divided into eight distinct vegetation zones, based on the existing vegetation and landscape features. These vegetation zones will be used to assist with revegetation and weed control, which will be guided by a detailed biodiversity action plan. The following vegetation zones are shown in Figure 9:

- Zone A: Revegetation site highly visible road corner
- Zone B: East-facing embankment above the watercourse
- Zone C: Watercourse (identified as a single unit)
- Zone D: West-facing embankment above the watercourse
- Zone E: Another section of the west-facing embankment
- Zone F: Rocky outcrop and the top of the rise
- Zone G: Ridgetop on the eastern side of the gully
- Zone H: Flat area at north-western end

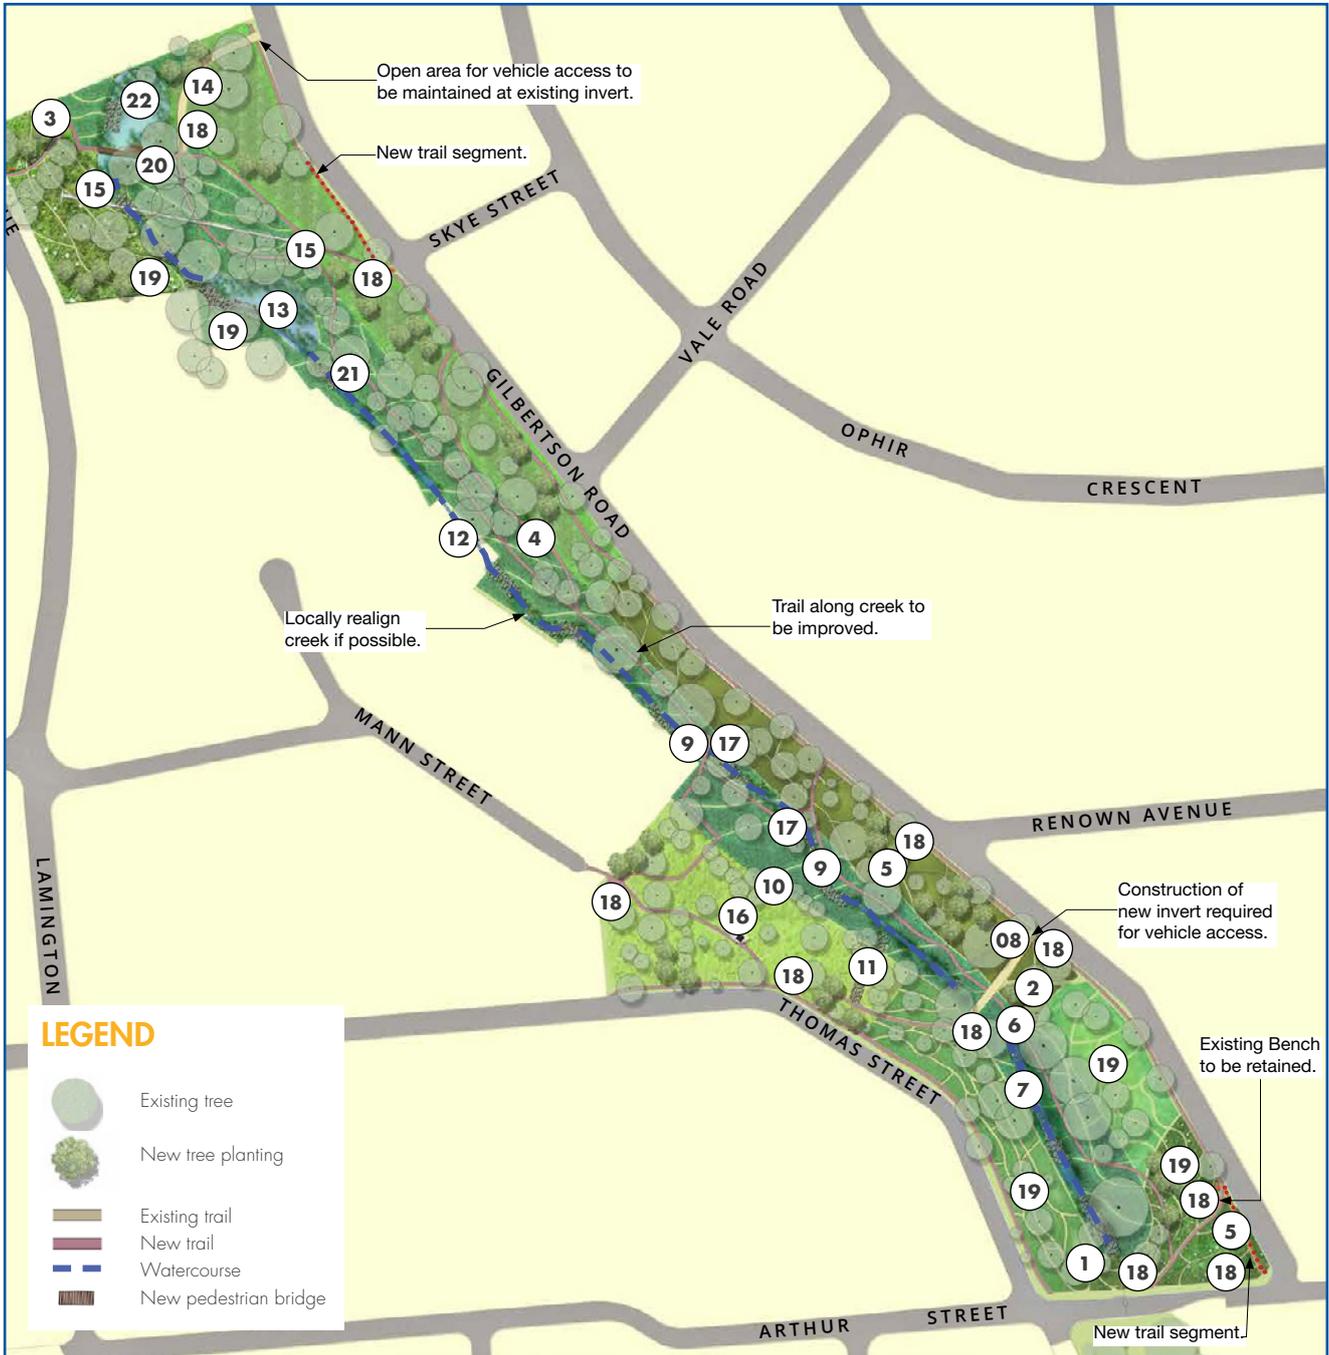
Figure 10. Gilbertson Gully masterplan recommendations.

1. Repair headwall apron, remediate and revegetate. Consideration of upstream gross pollutant trap (GPT) possible
2. Stabilise embankment
3. Upgrade and consider possible/minor realignment of steps for improved access and reduced grades and erosion

4. Realign existing trail higher on bank, away from watercourse (as well as maintaining path along watercourse)
5. Formalised and enhanced trail network

6. Installation of new trash rack or WWSUD treatment to reduce blockages
7. Undertake watercourse improvements: clean-out of existing basin and create new low flow channel, various locations

8. Vehicle access for basin/ trash rack maintenance
9. Remediation of channel
10. Rocky outcrop maintained
11. Improve stormwater outlet
12. Creekline on private property. Assess options

13. Location of new water quality basin
14. Improve vehicle access for maintenance to water quality improvement basins
15. Liaise with SA Water to repair pipe headwalls

16. New informal seating
17. New watercourse crossing - location to be determined on site
18. Existing monuments and signage retained
19. Existing revegetation

20. New watercourse crossing and informal seating
21. Lookout point at edge of basin
22. Improve downstream outlet arrangement

The recommendations outlined in this section provide direction to enhance the existing biodiversity, reduce erosion, and improve access and amenity for the community to enjoy the natural environment of the gully. Figure 10 shows the location for each of the recommendations.

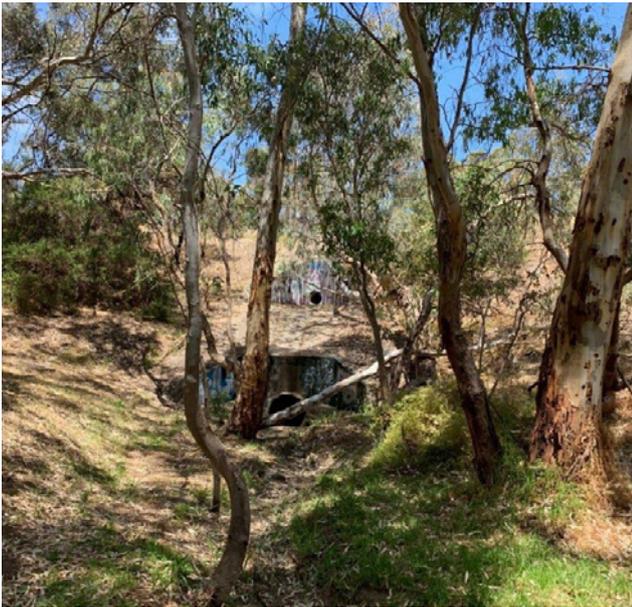
Figure 11. Upstream drainage infrastructure.

An embankment currently crosses the gully, with low-flow culverts projecting through it, effectively forming a detention basin in large stormwater events. Whilst the detention has no significant impact on downstream flood flows, it provides an opportunity to create a small wetland. The culvert entry has trash screens installed, however, these are observed to be regularly clogged with debris, and significantly restrict drainage into the culverts. This should be reviewed and an alternative solution developed that does not require

significant maintenance and can retain small amounts of water to create a small wetland. The installation of an upstream GPT near Arthur Street could also help to reduce loadings of leaf litter.

There is also an opportunity to excavate in front of the embankment, within this detention area, to allow for additional ponding, water retention and sedimentation, which will improve water quality and assist in mitigating culvert blockages.

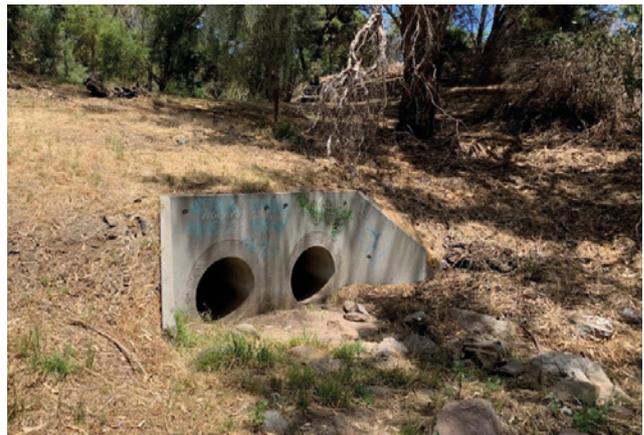
Figure 12. Downstream outlet detention basin.

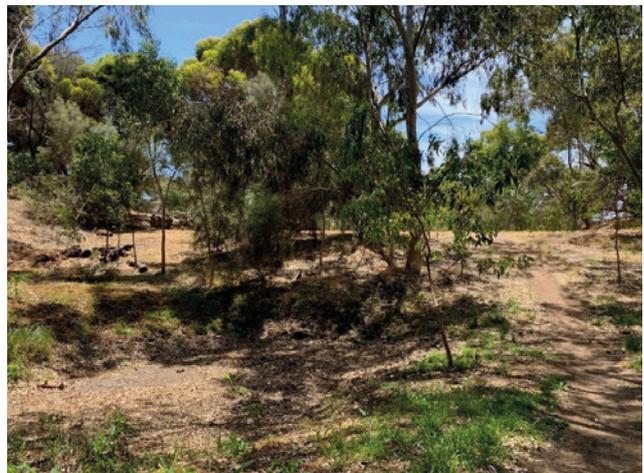
Figure 13. Upstream of existing detention basin.

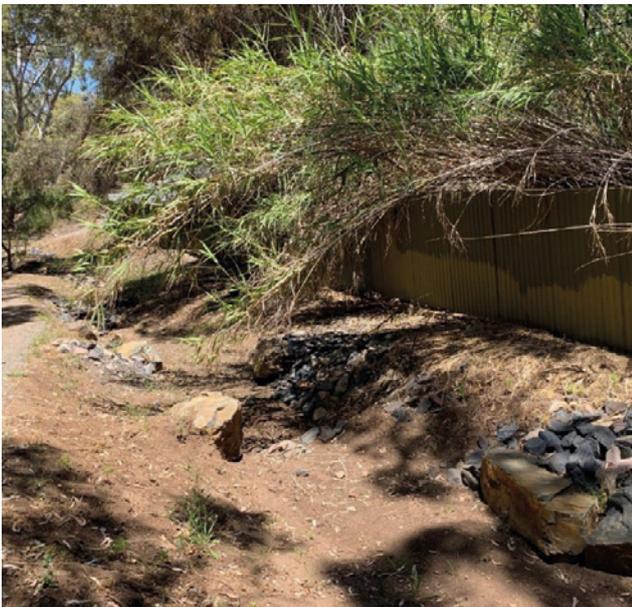
Figure 14. Erosion along drainage line.

The main drainage line along the gully shows sign of erosion at several locations and it is recommended that any eroded areas be remediated, and erosion protection measures deployed to minimise future ongoing erosion. There are several options that may be considered for erosion protection, including:

- Rock lining along incised sections of the gully invert
- Rock “leaky” check-dams
- Turf reinforcement mat with vegetation.

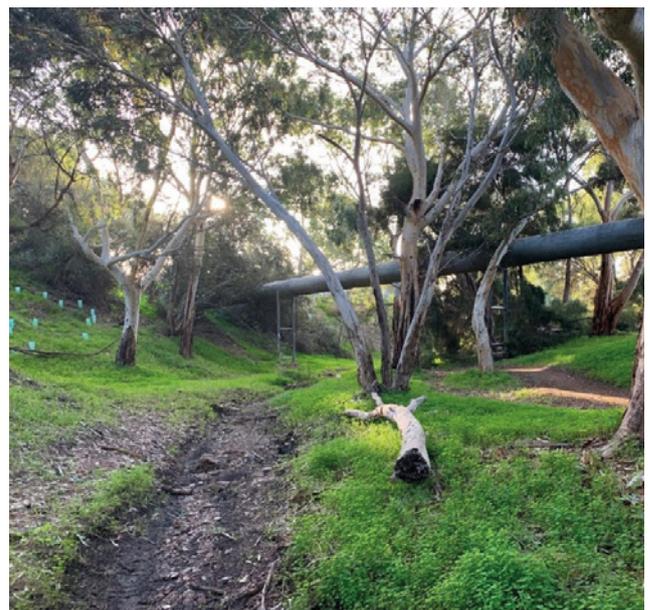
Figure 15. Water supply crossing.

The headwall surrounds and the exposed structure to the above ground water supply pipeline crossing near Gilbertson Road has deteriorated and it is recommended that Council liaise with SA Water to assess and remedy if required.
