Council Report No: 328/22

# **H-CLASS TRAM OPTIONS**

# CONDITION ASSESSMENT AND CONCEPT REPORT

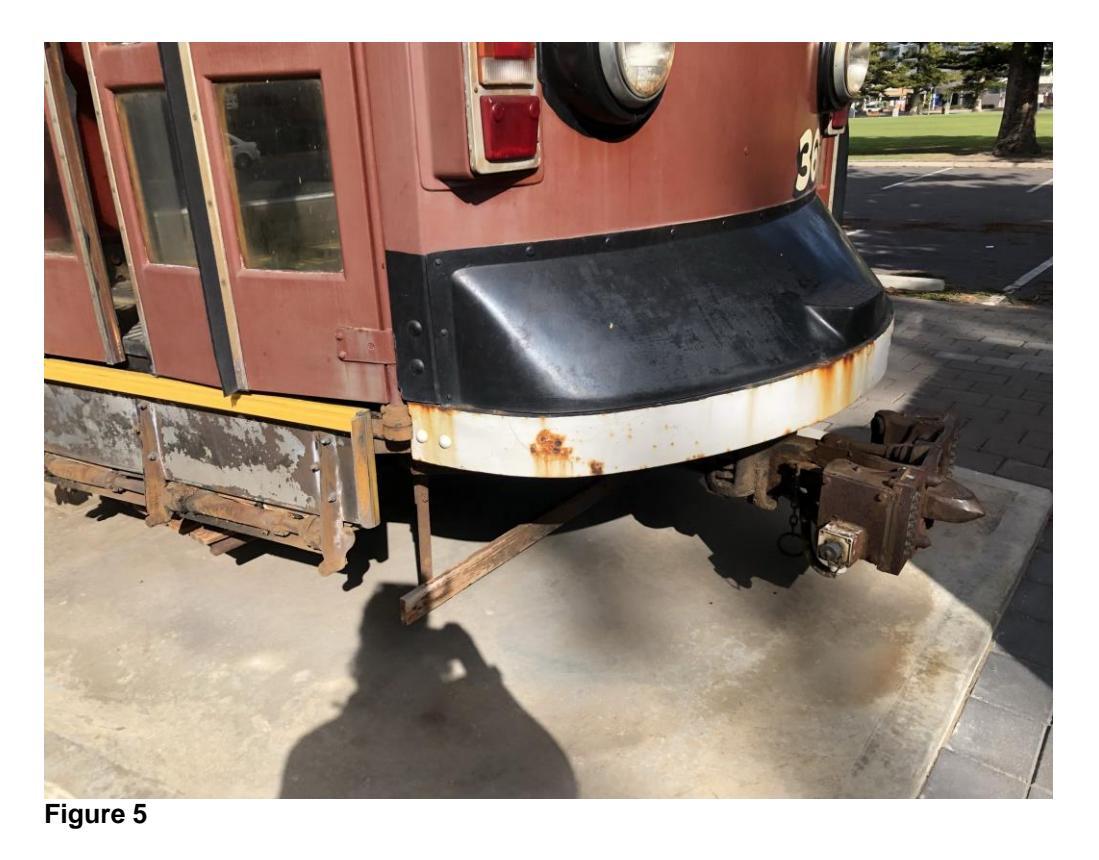
- Moderate corrosion to the hinge assembly for the step. (figure 4)
- Moderate to severe laminated corrosion to the steel plate at each end of the tram. (figure 5)

Corrosion to the door hinge assemblies may eventually inhibit or prevent the door from opening effectively. Hence, this should be rectified.

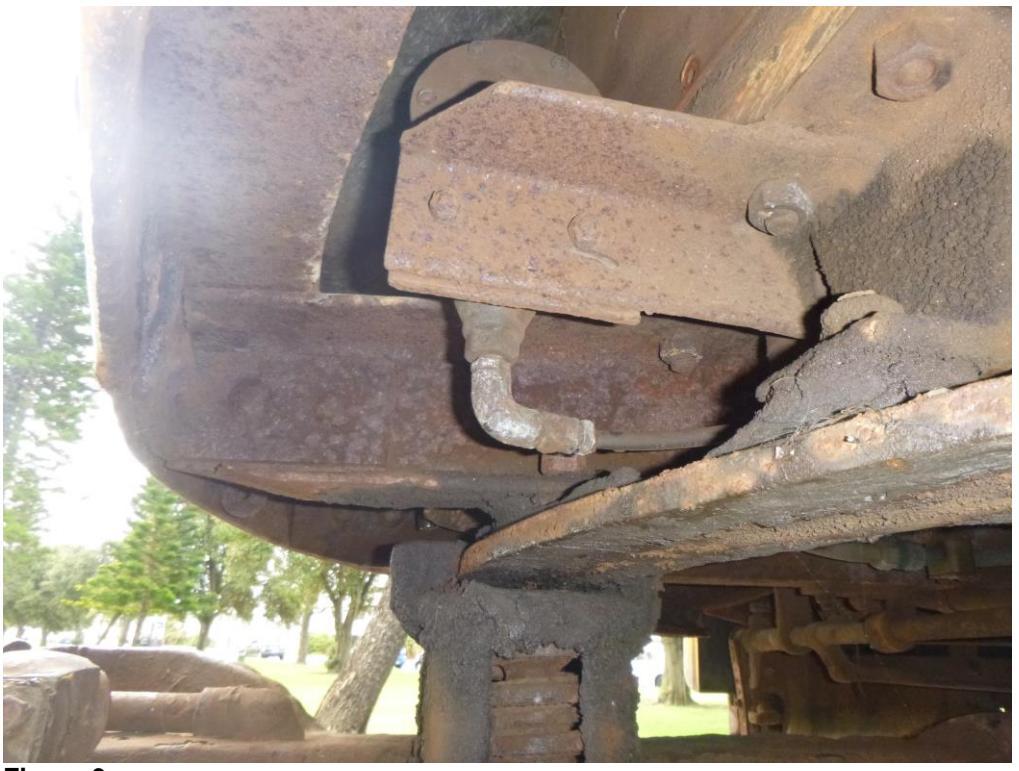
- Moderate to severe corrosion to the undercarriage steel chassis members, which are steel I-beams and equal angles. These critical elements form the structural frame for the tram. (figure 7-9)

- Moderate surface corrosion to the undercarriage componentry generally. (figure 7-9)
- Moderate corrosion to the wheels and bogie assembly. (figure 11)

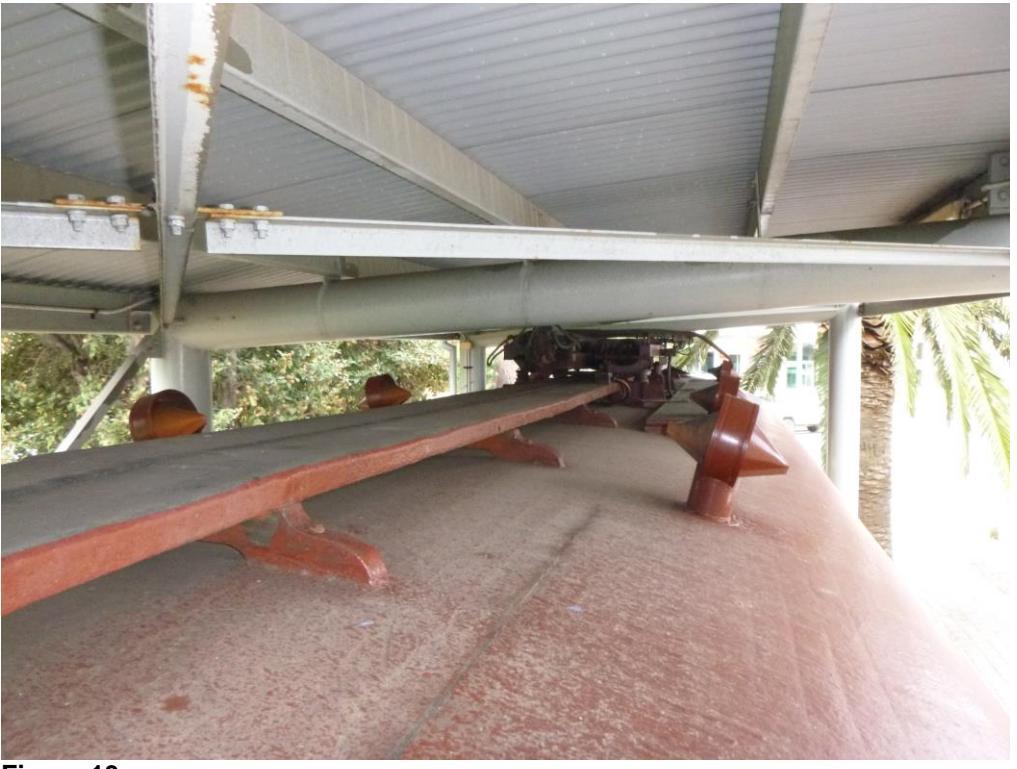
Figure 12

- Broken light at the eastern end of the tram. (figure 12)
- The roof of the tram appeared in reasonable condition, with minimal signs of paint failure or corrosion. (figure 13)
