Item No: **15.4**

Subject: **TARLTON STREET TREE ASSESSMENT AND TREE RENEWAL**

Tarlton Street *Quercus ilex* (Holm Oak) Assessment Report

**Prepared for Council
Compiled by Ben Hall, Technical Arboriculture Officer**

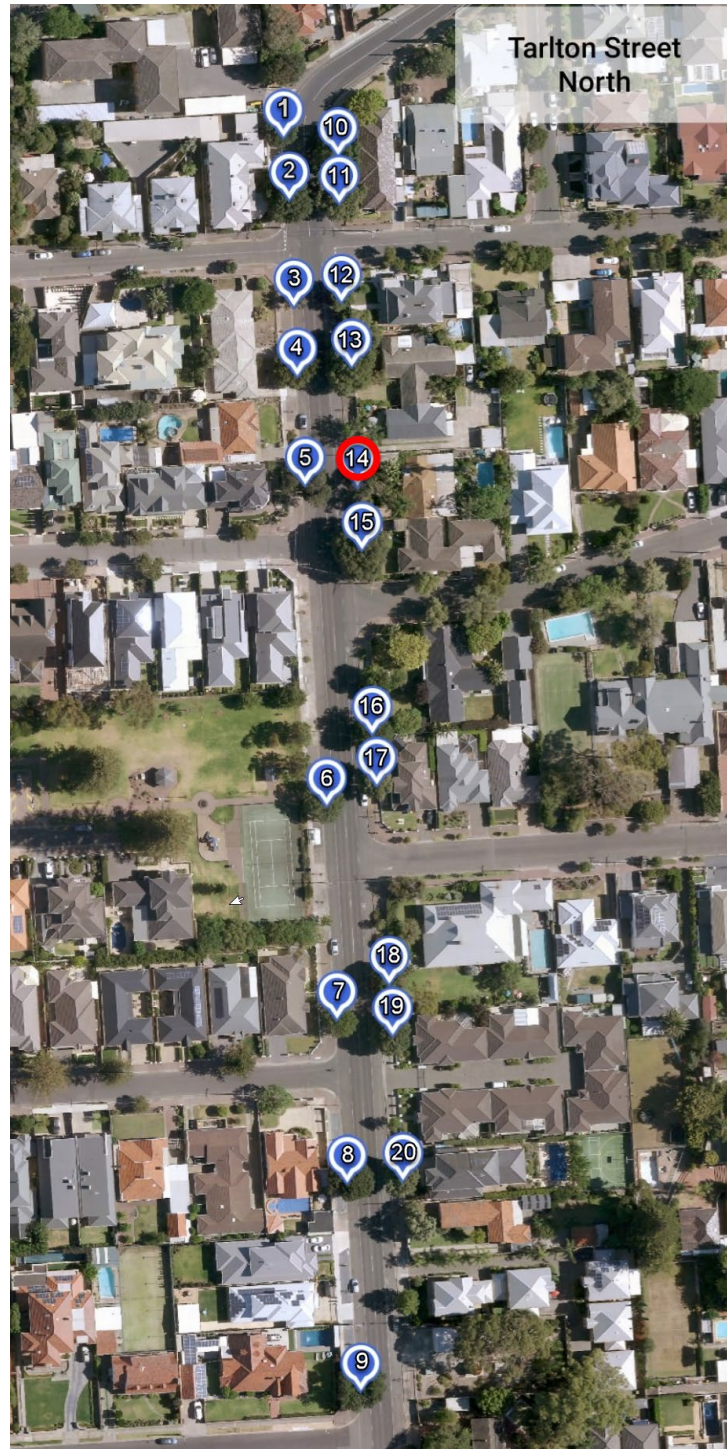
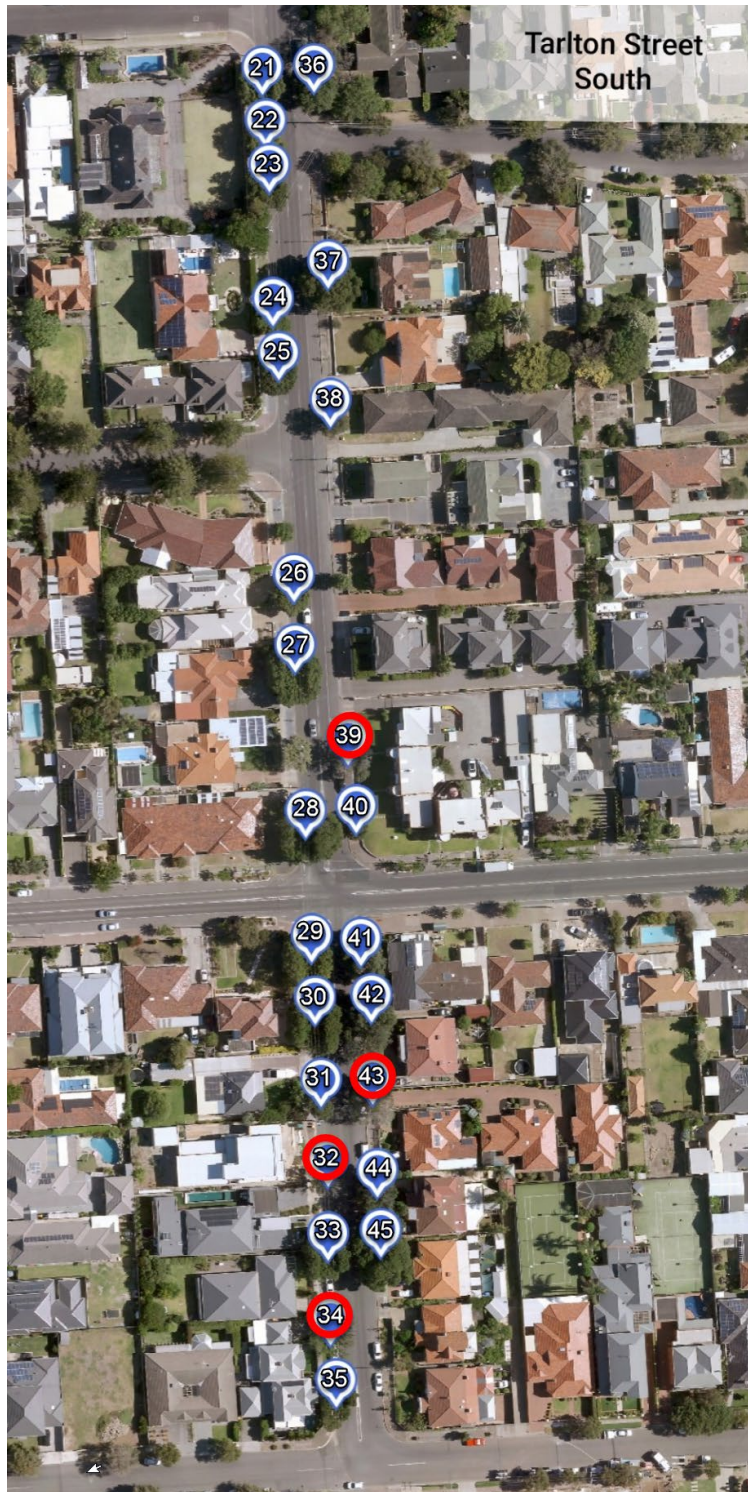
Identification Data Map

All vegetation assessed has been labelled 1 to 45, as per aerial imagery. Reference to the allocated identification labels correlate to the detailed vegetation assessment. To give further indication, the recommended removals have been highlighted in red.
